*On Board
Diagnostics*

**CHRYSLER
CORPORATION**

On-Board Diagnostics

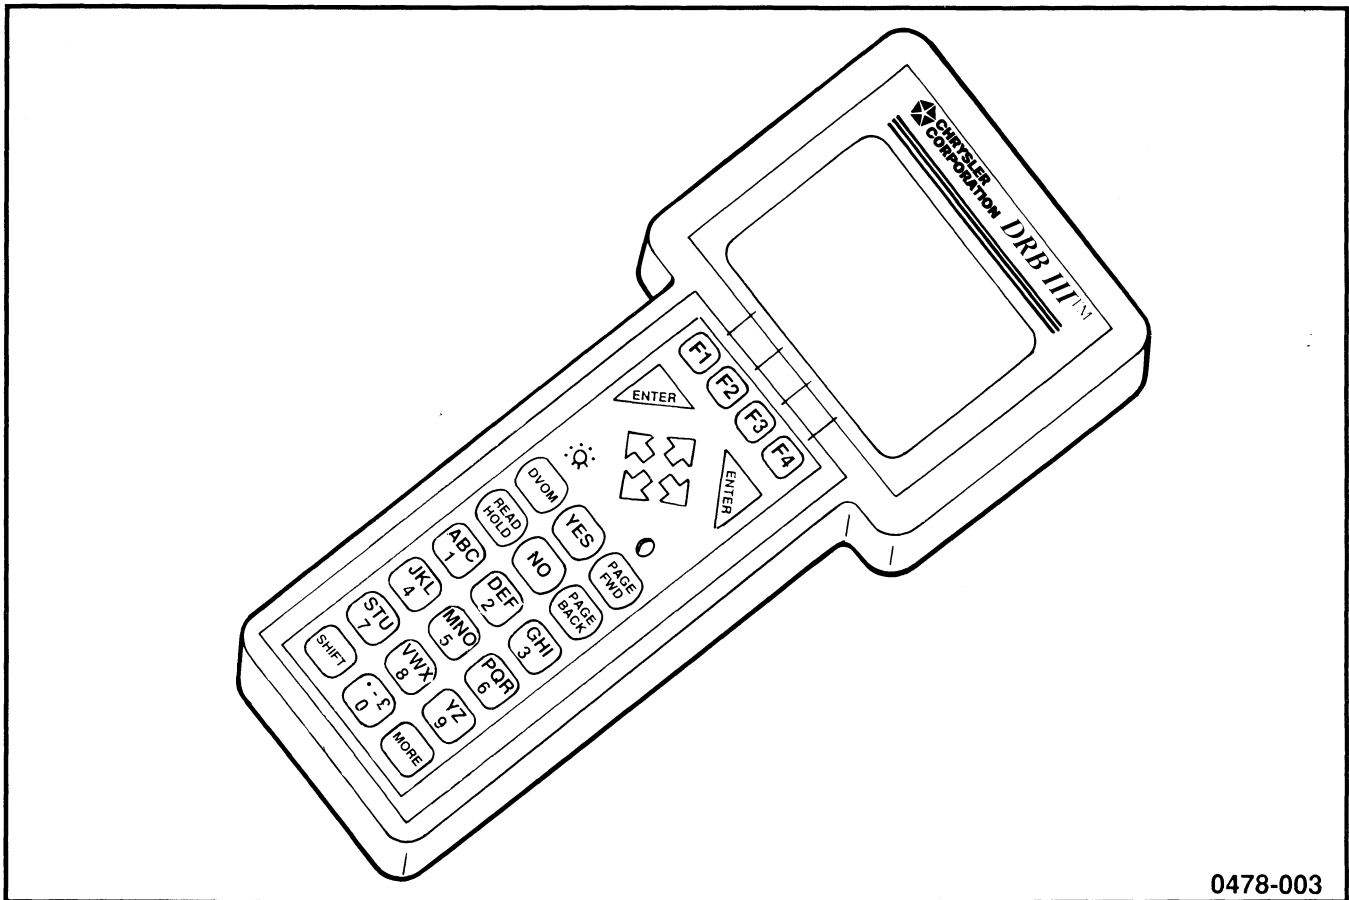
0478-003

Figure 3 DRB III Diagnostic Scan Tool

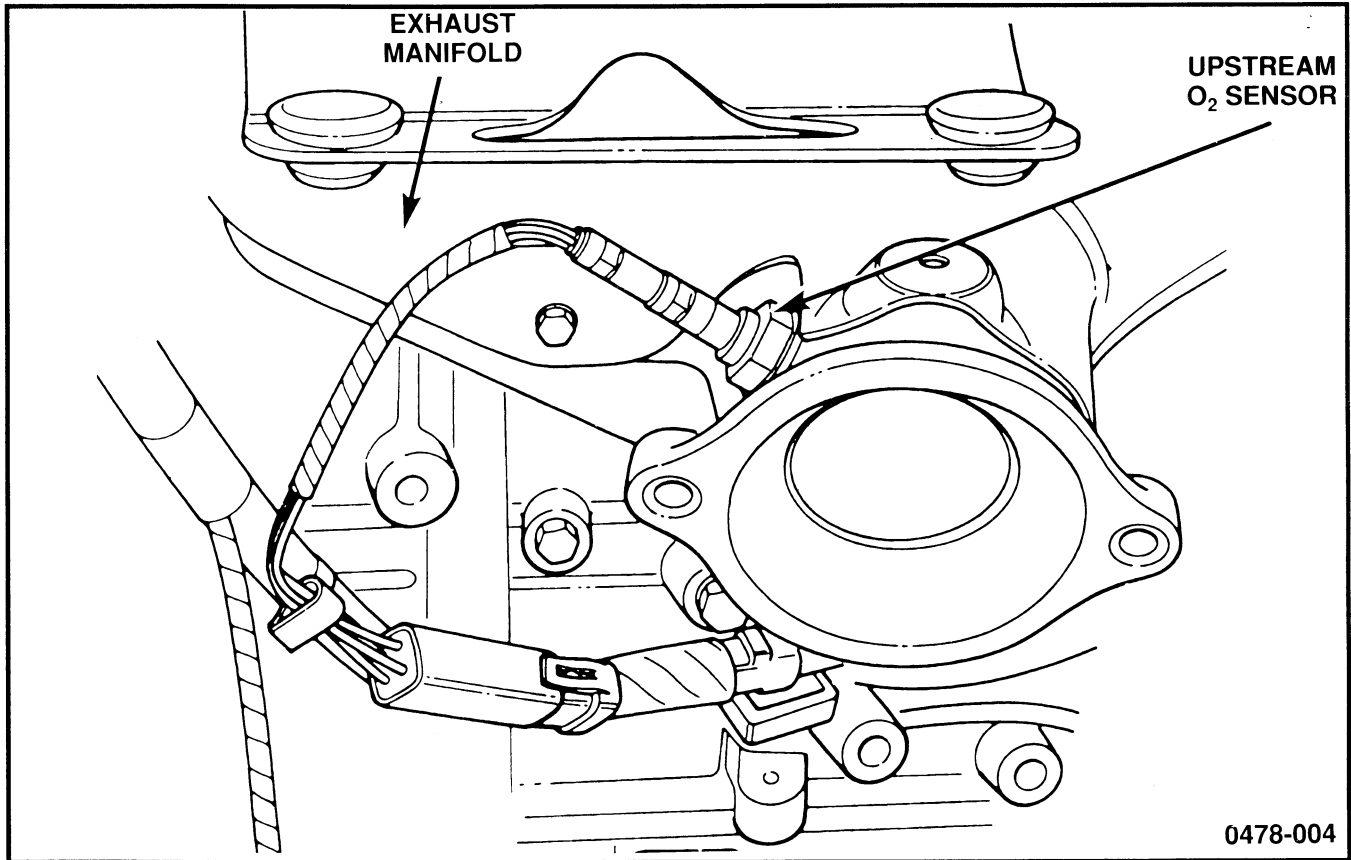
Figure 4 Oxygen Sensor

Effective control of exhaust emissions is achieved by an oxygen feedback system. The most important element in this system is the upstream oxygen (O_2) sensor mounted in the exhaust manifold (fig. 4).

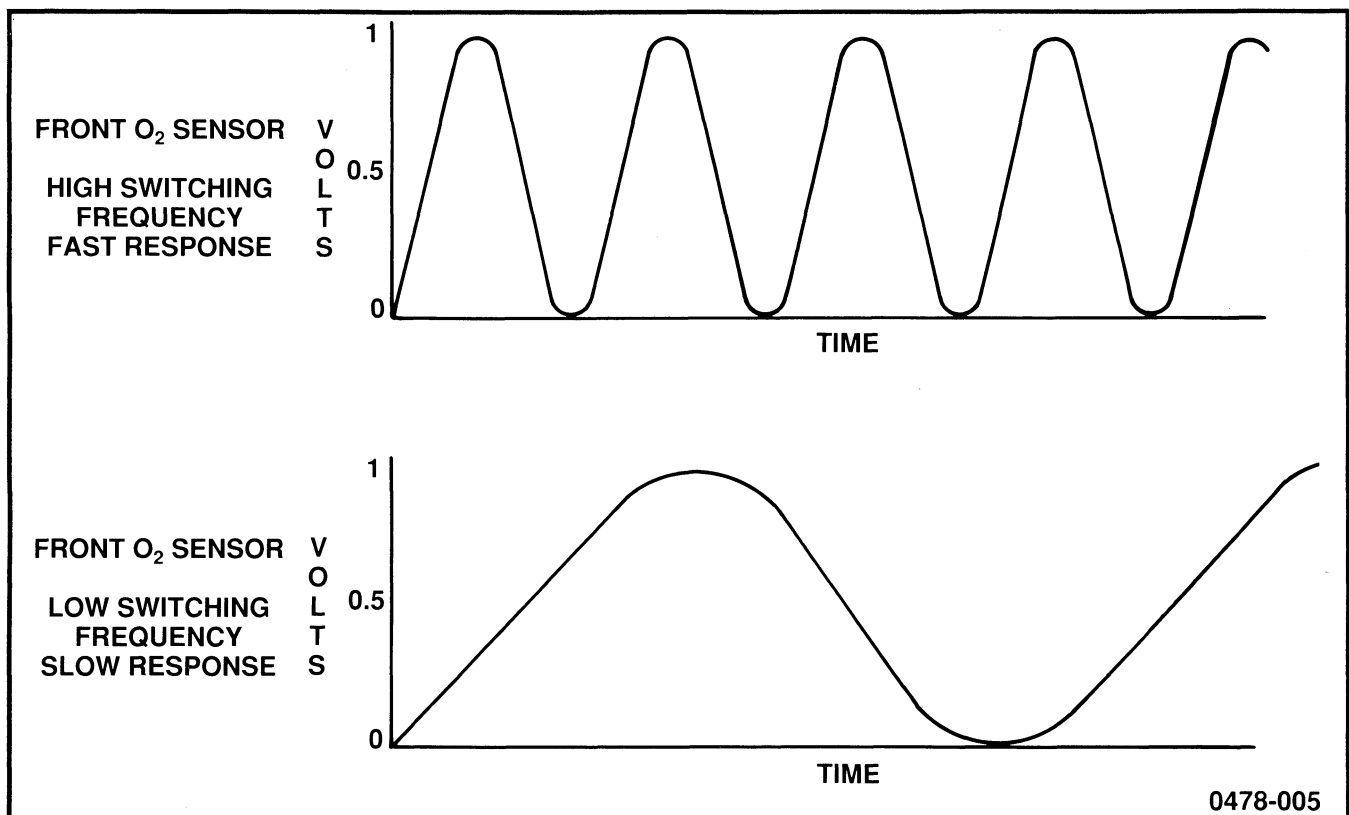
Figure 5 Switching Frequency Response

A slow response rate (fig. 5), or reduced voltage output are both signs of an improperly operating oxygen sensor. This could mean longer instances of combustion of less-than-optimum air/fuel mixtures, which can significantly increase emissions.

The O₂ sensor must have a voltage output of greater than 0.745 volt in order to pass the test. It must also switch more times during a 120-second period than a pre-determined threshold (to demonstrate quick response), or produce a pre-determined number of steep-slope switches (demonstrating dynamic range and quick response) over the same time period. Data is not stored unless idle time exceeds ten seconds.

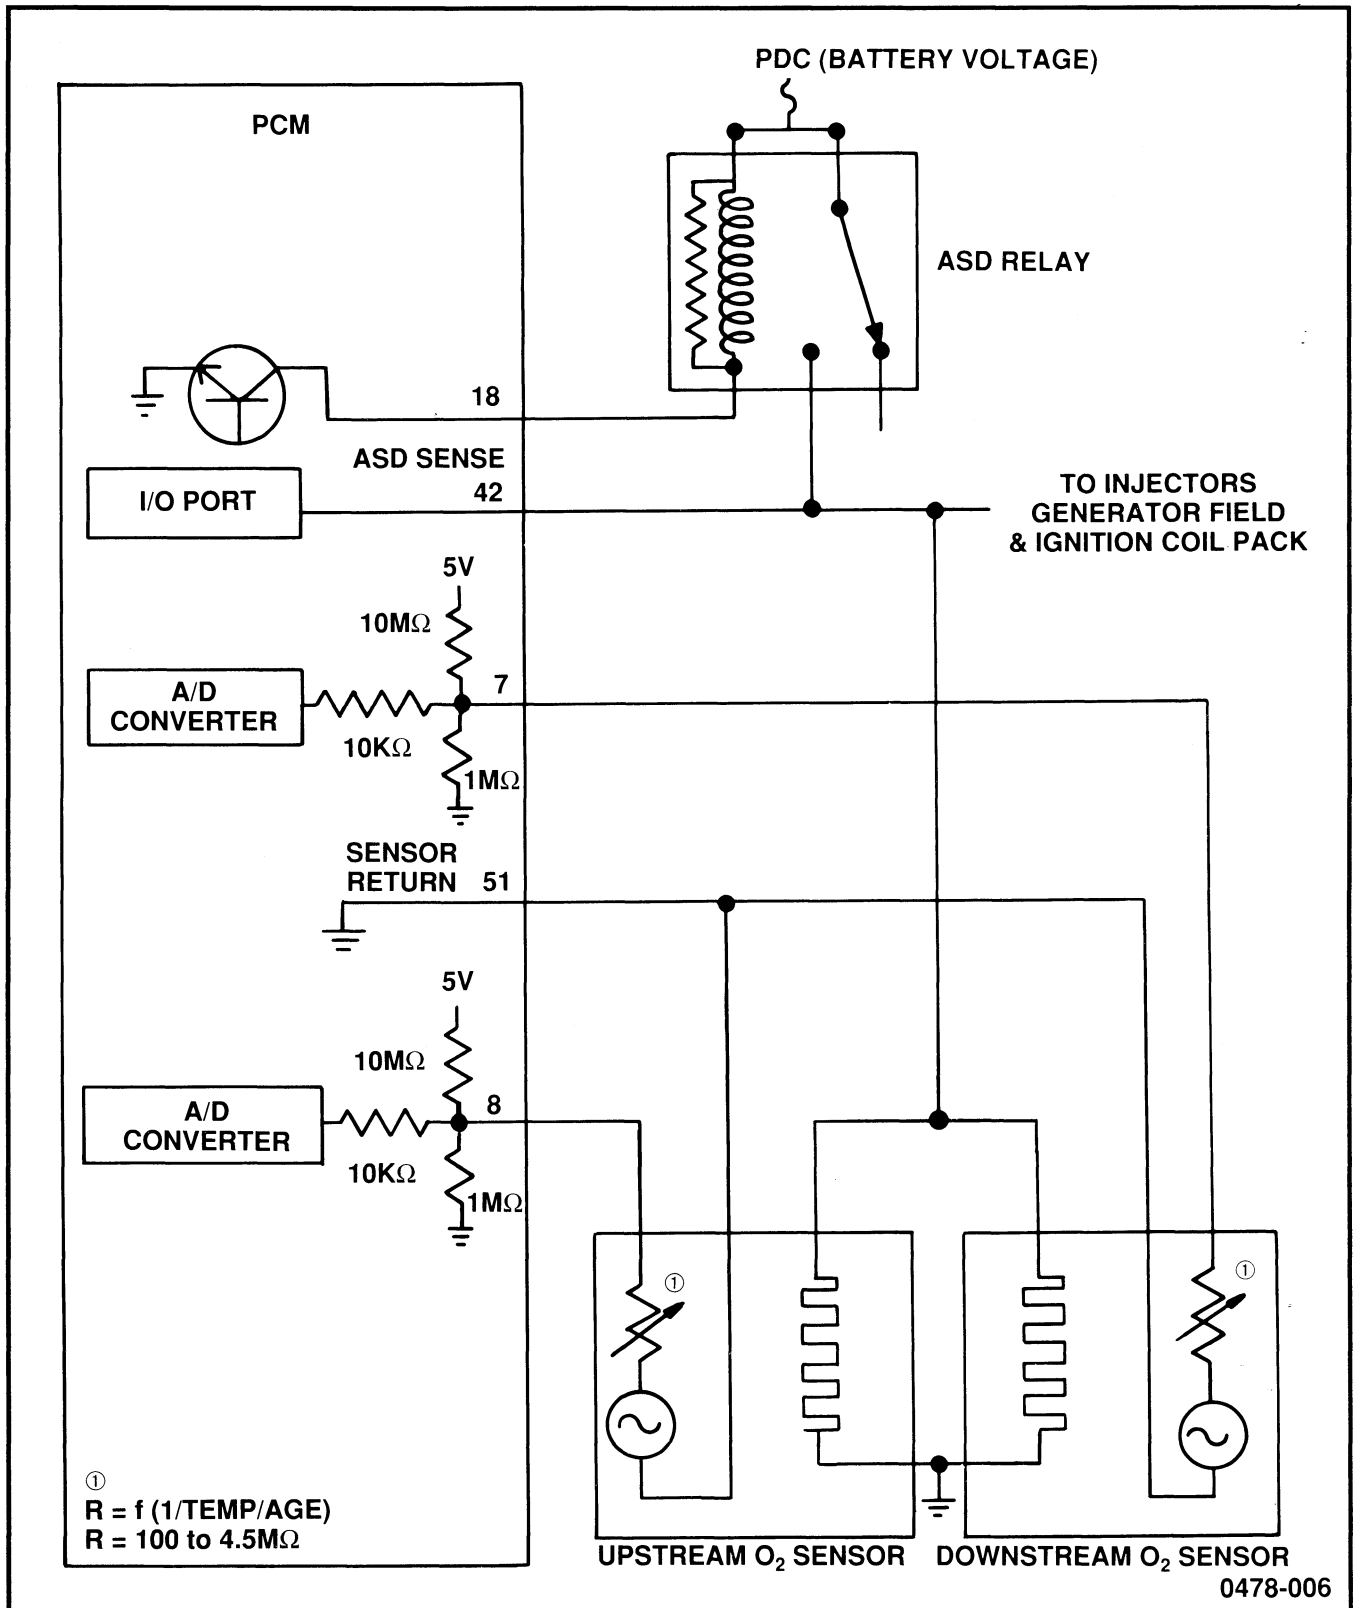
Figure 6 O₂ Sensor Wiring

- Exhaust system (leaks)
 - Pipes
 - Manifold
 - Catalytic converter
 - Seals
- Wiring (fig. 6) and harness and connectors
- Fuel
- PCM

When the key is turned to the RUN position, the O₂ sensor's output wire is biased inside the PCM with a voltage of 0.45 volts (fig. 6). The PCM monitors the O₂ sensor for a change in the biased voltage. As oxygen in the exhaust supply changes, the O₂ sensor's output voltage changes. A voltage less than 0.45 volt indicates excessive oxygen in the exhaust. A voltage greater than 0.47 volt indicates insufficient oxygen in the exhaust. The PCM uses the information from the O₂ sensor to assist in adjusting the air/fuel ratio to a stoichiometric ratio.

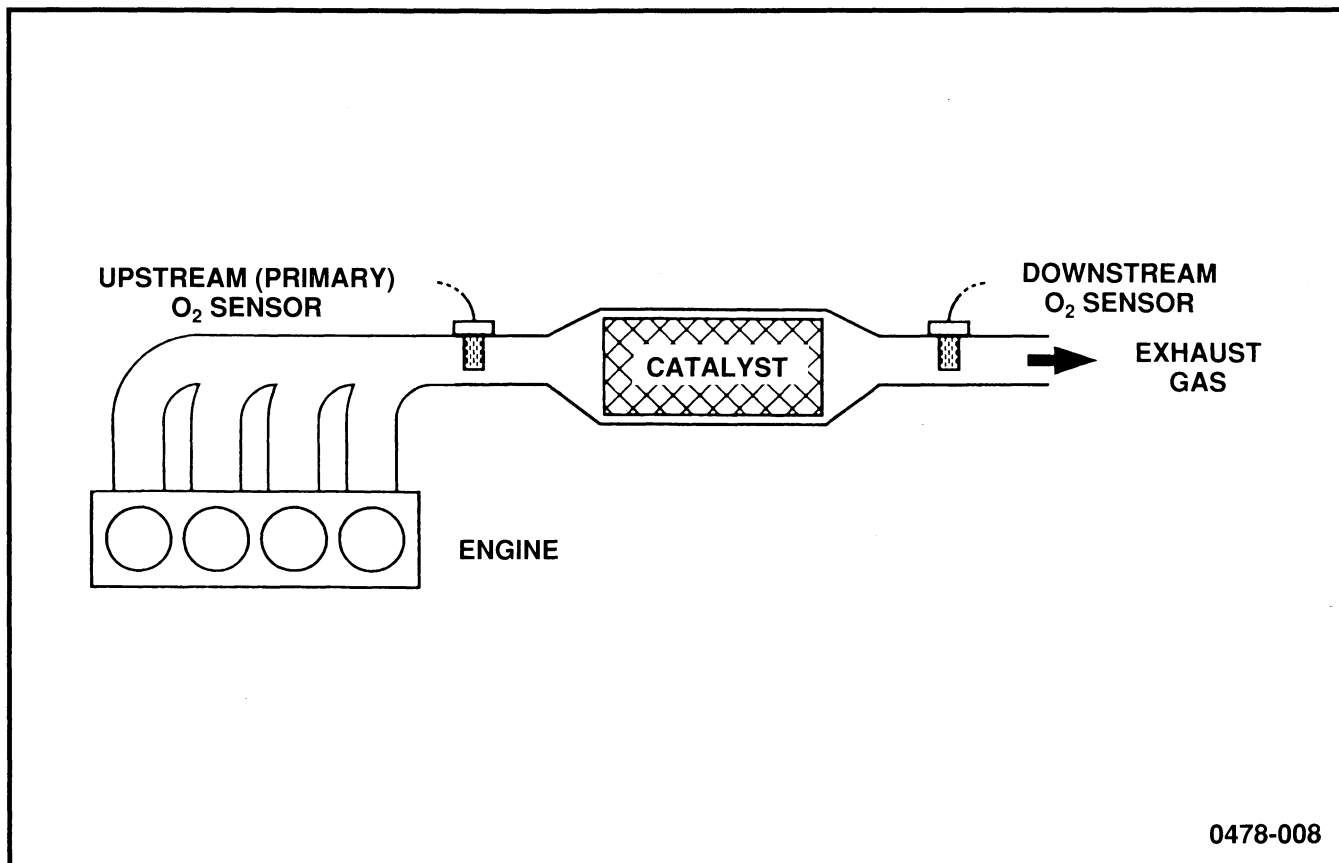
Figure 8 Oxygen Sensor Locations

O₂ sensors located above (upstream) and below (downstream) the catalytic converter (fig. 8) are able to monitor the efficiency of the converter. The dual O₂ sensor strategy is based on the fact that, as a catalyst deteriorates, its oxygen storage capacity and efficiency are both reduced. By monitoring the oxygen storage capacity of the catalyst, its efficiency can be indirectly calculated. The upstream sensor detects the amount of oxygen in the exhaust gas before it enters the converter. This sensor should switch fairly rapidly.

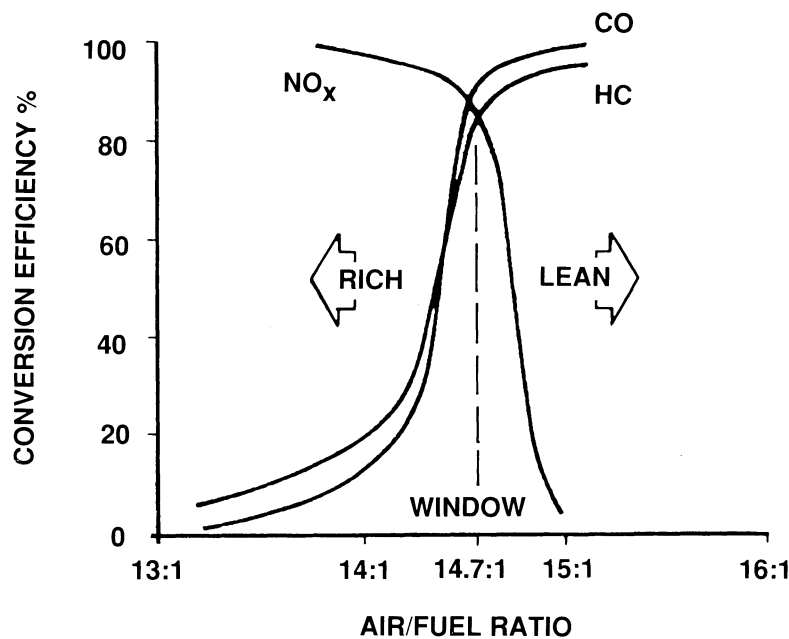
0478-010

Figure 10 Conversion Efficiencies of a Three-Way Catalyst

To control the level of undesirable emissions, the fuel system must be able to maintain strict control of the air/fuel ratio. The stoichiometric air/fuel ratio (14.7:1) is optimum. At that ratio, the best balance between the production of HC's and CO's (which drop as the mixture becomes leaner) and NO_x (which increases as the air/fuel mix becomes leaner) can be found (fig. 10). This is also the point where the catalytic converter is most efficient at converting all three gases to less harmful compounds. The goal of the PCM is to examine input information and control outputs to produce a constant stoichiometric ratio.

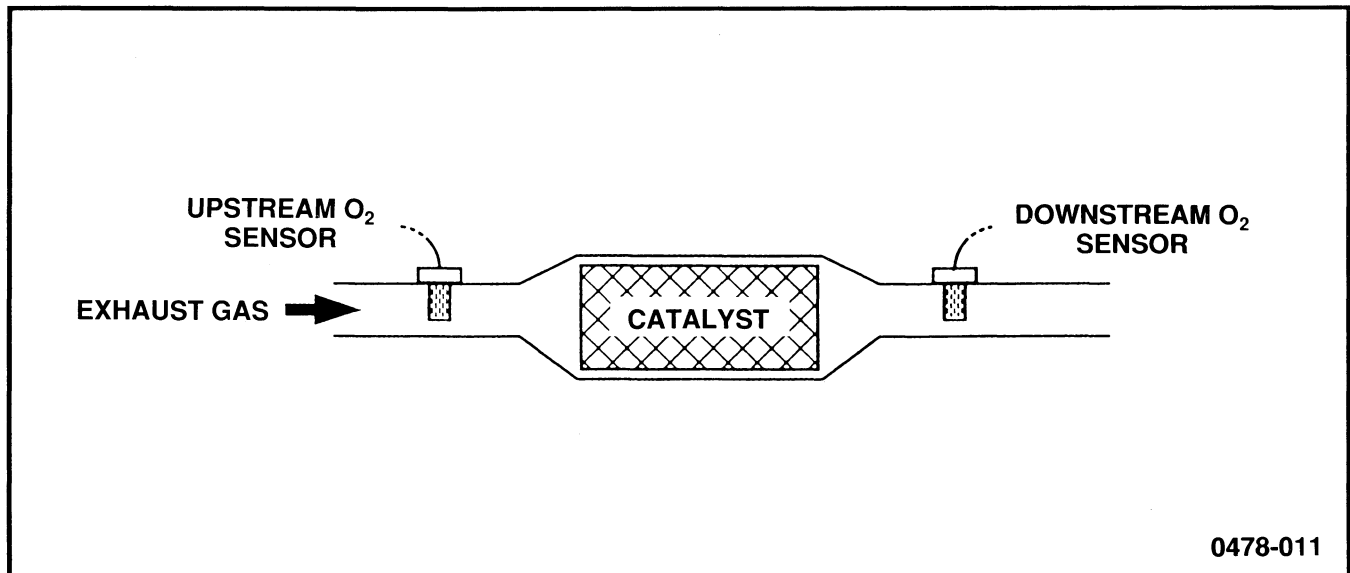
Figure 11 O₂ Sensors

As noted earlier, the Neon uses two oxygen sensors (fig. 11), both of which monitor the oxygen content of the combustion byproducts on their way out of the engine as exhaust. Only the upstream sensor has authority over fuel injector pulse width.

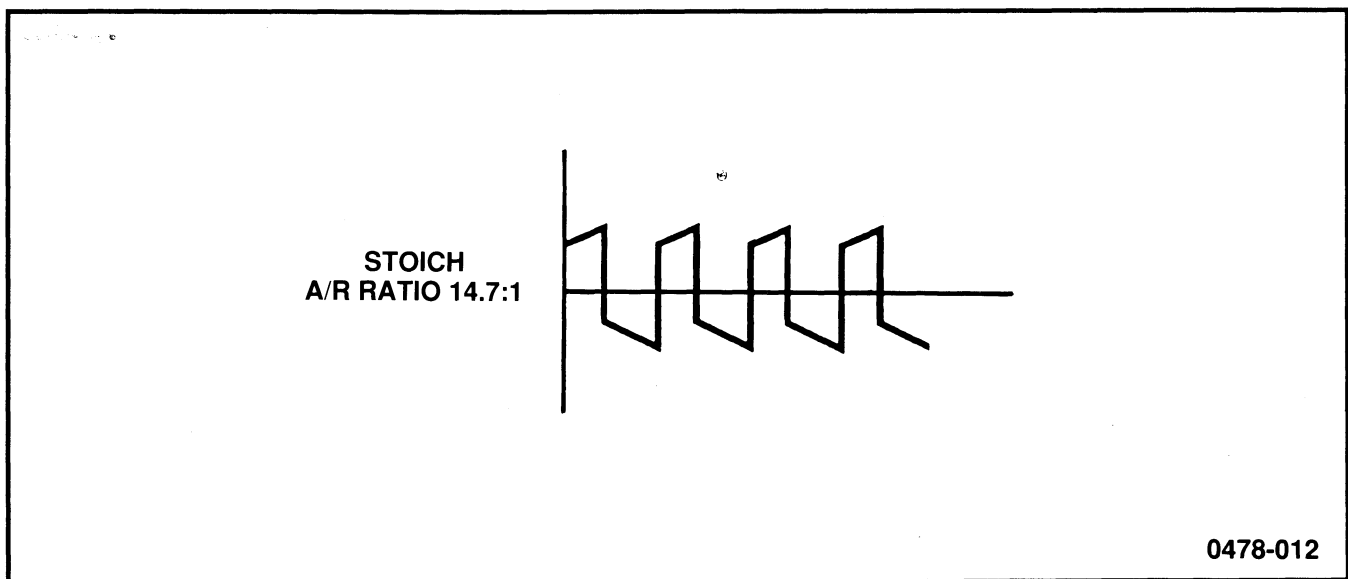
Figure 12 Short-Term Fuel Compensation

If, during vehicle operation, the oxygen sensor registers a rich or lean condition in this cell, the cell will require updating to aid in fuel control. The short term correction is used first. It starts increasing pulse width quickly (kick), then ramps up slowly (fig. 12). Each control is in inverse relation to the signal sent from the O₂ sensor.

The O₂ sensor switches lean to rich. Short term compensation kicks-in lean, then ramps lean until the O₂ sensor switches rich. At this point short term compensation reverses the process.

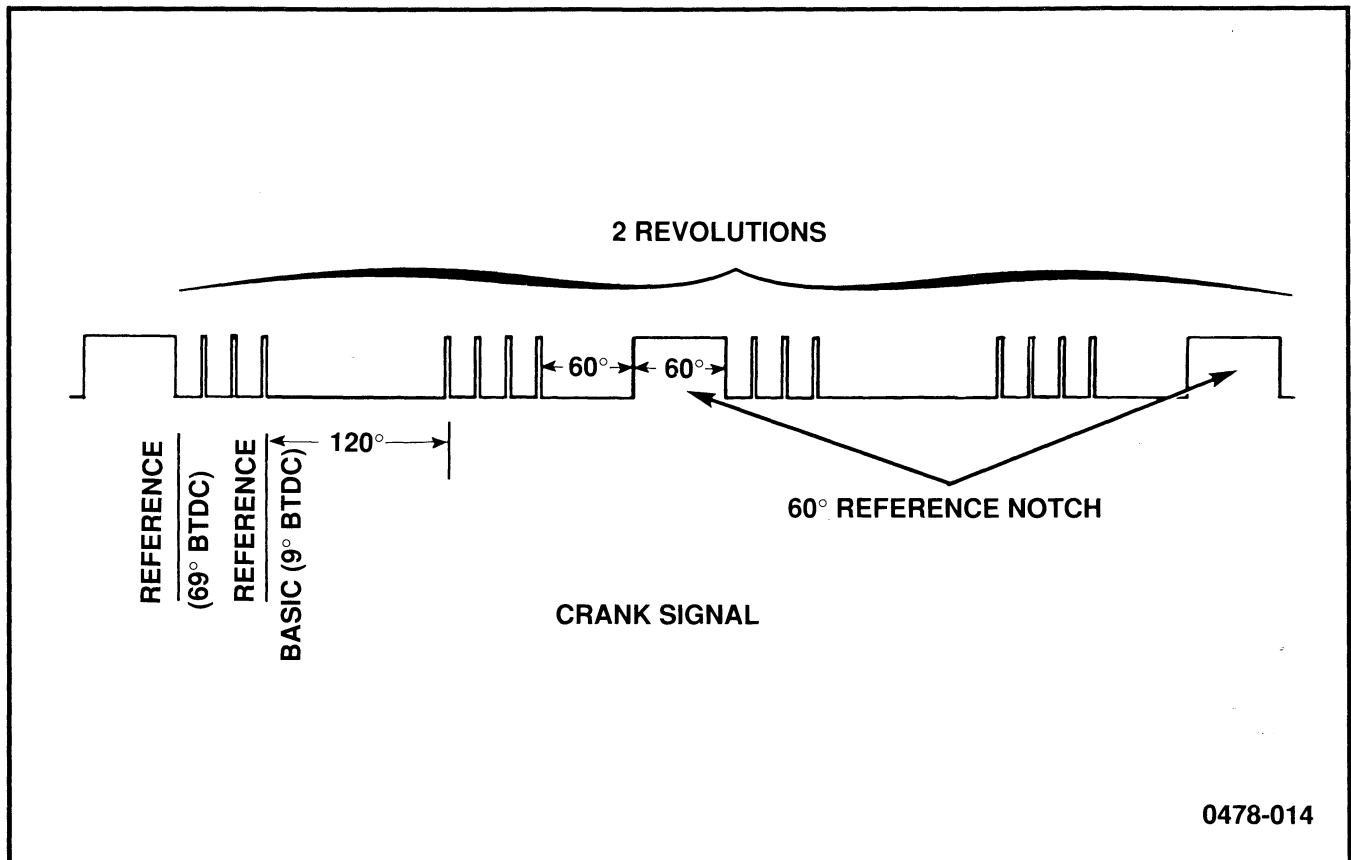
Figure 14 Crankshaft Position Sensor Signal

The OBD II misfire monitor uses information provided by the crank position sensor to determine engine rpm and detect slight variations due to engine misfire. Crankshaft rpm is calculated between the 69° and 9° falling edges of the crankshaft position sensor signal (fig. 14).

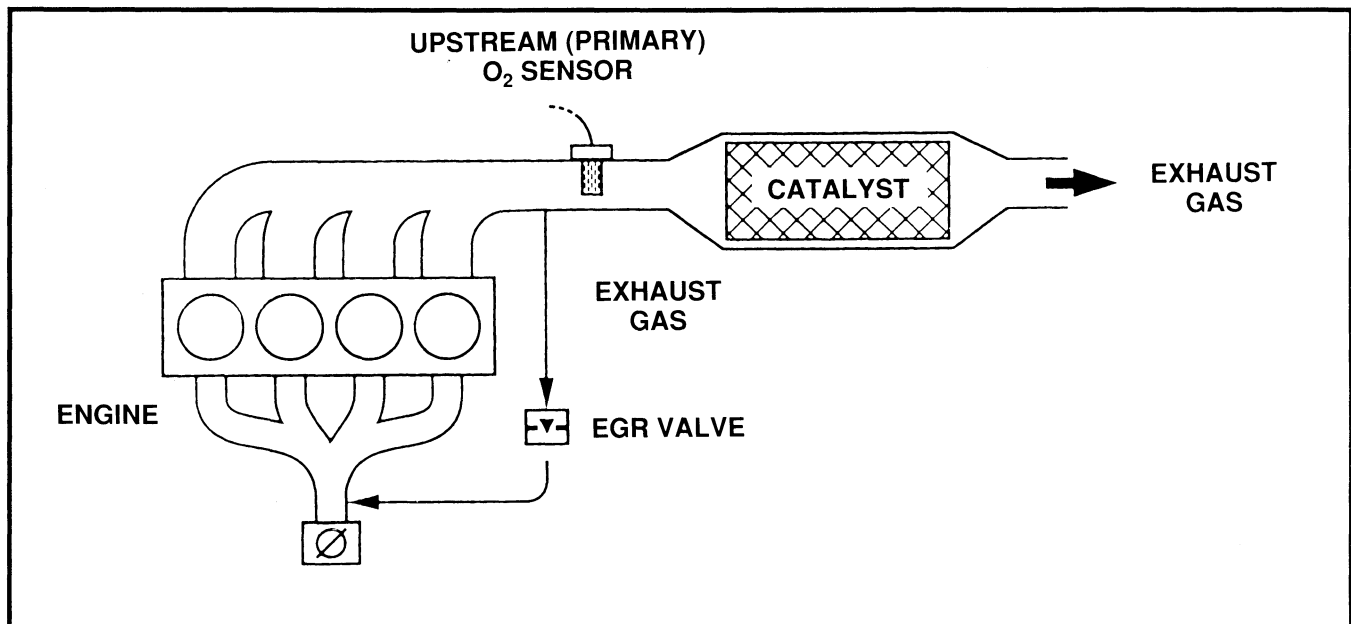
Figure 15 Exhaust Gas Recirculation System

Exhaust Gas Recirculation (EGR) is a method of reducing oxides of nitrogen (NO_x) emissions by introducing non-combustible exhaust gases into the combustion chamber (fig. 15). These gases absorb heat and reduce the high cylinder operating temperatures where NO_x is most likely to occur. Lower combustion chamber temperatures result in lower NO_x emissions.

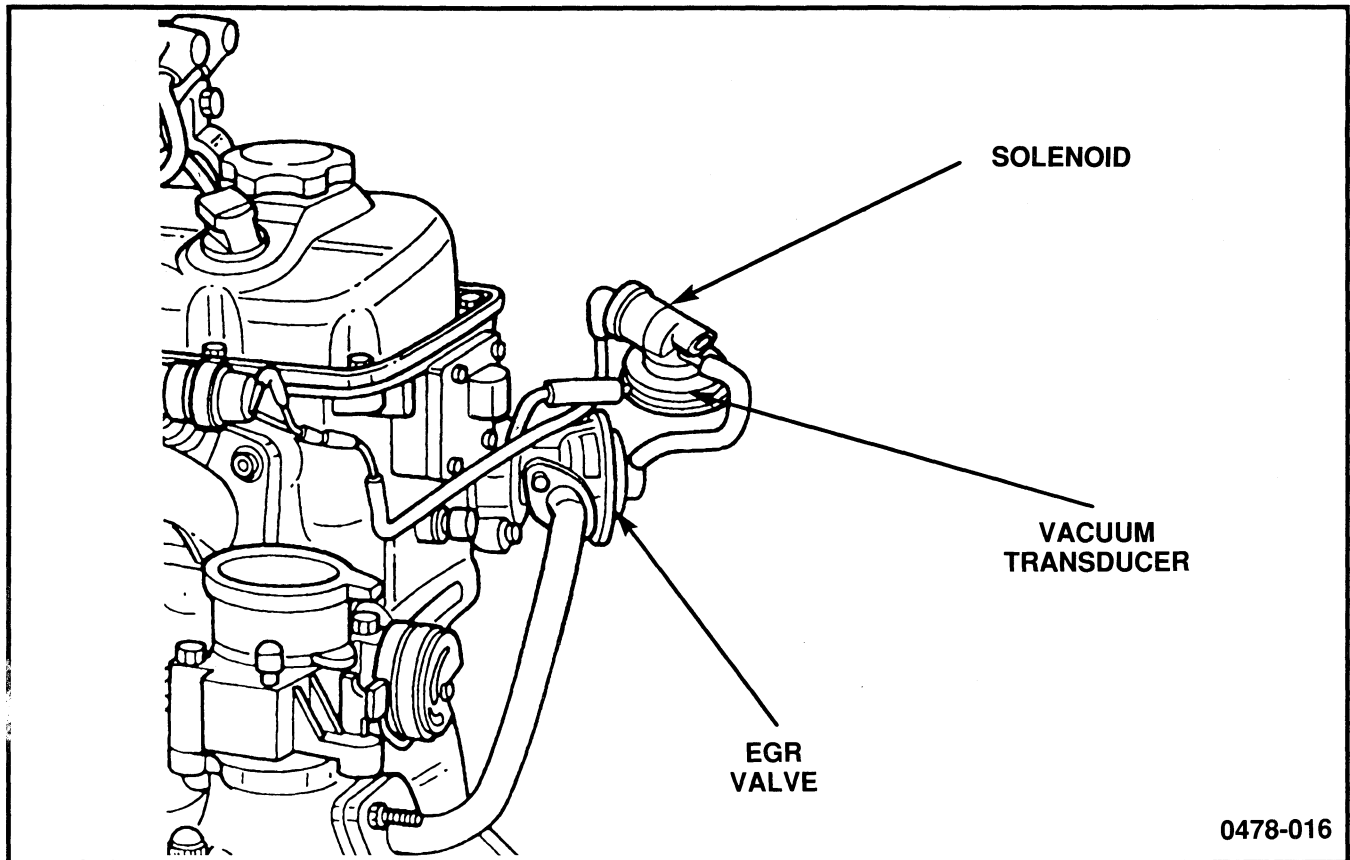
Figure 16 EGR Valve and Transducer

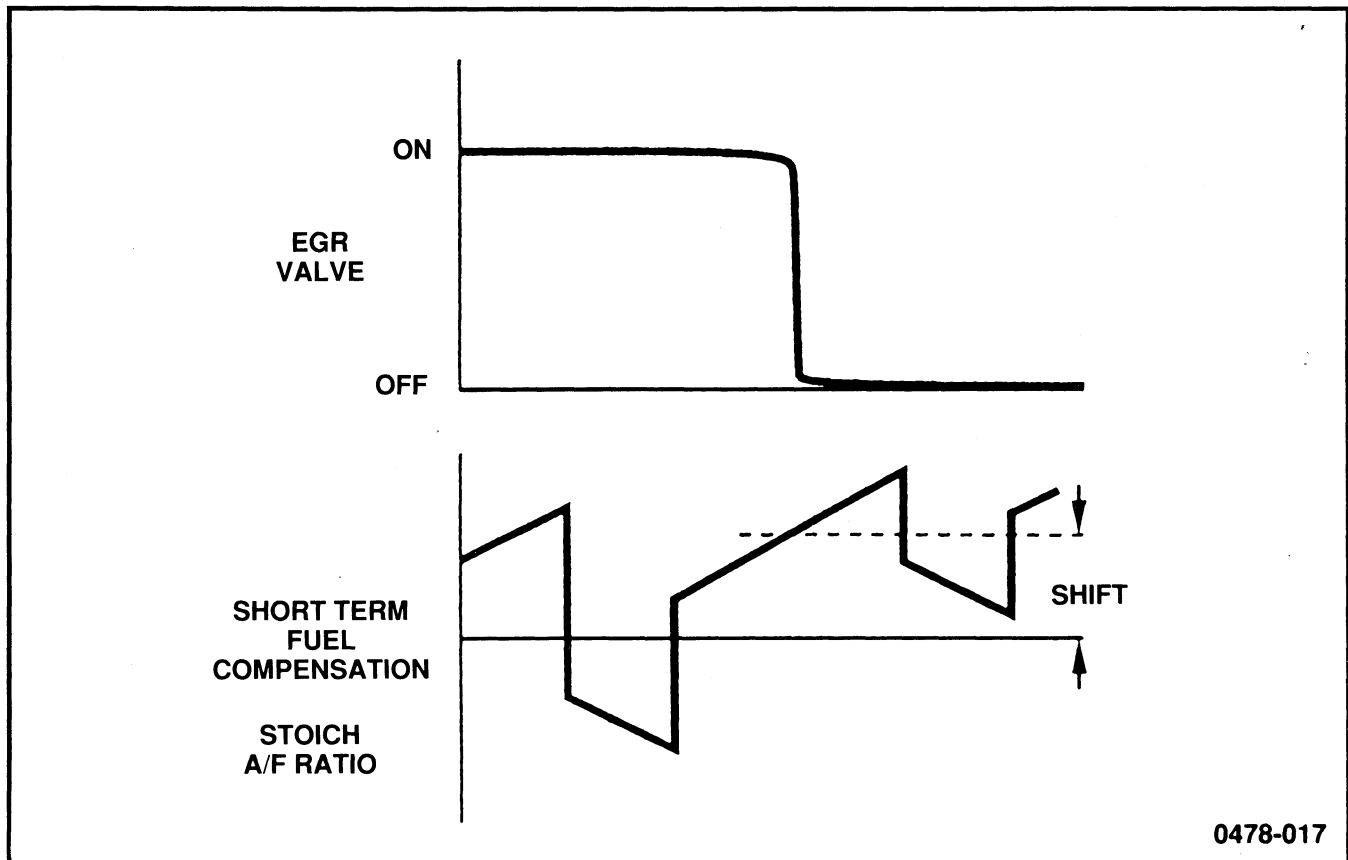
Figure 17 Fuel System Compensation Shift

To detect operation of the system, automatic fuel compensation is temporarily disabled, the EGR solenoid is turned off, and the O₂ compensation control is monitored. If the EGR system is operating properly, turning it off shifts the air/fuel ratio in the lean direction (fig. 17). O₂ sensor data should indicate an increase in oxygen in the exhaust gases, and cause the short term control to shift to rich. The amount of the shift indirectly monitors the operation of the system.

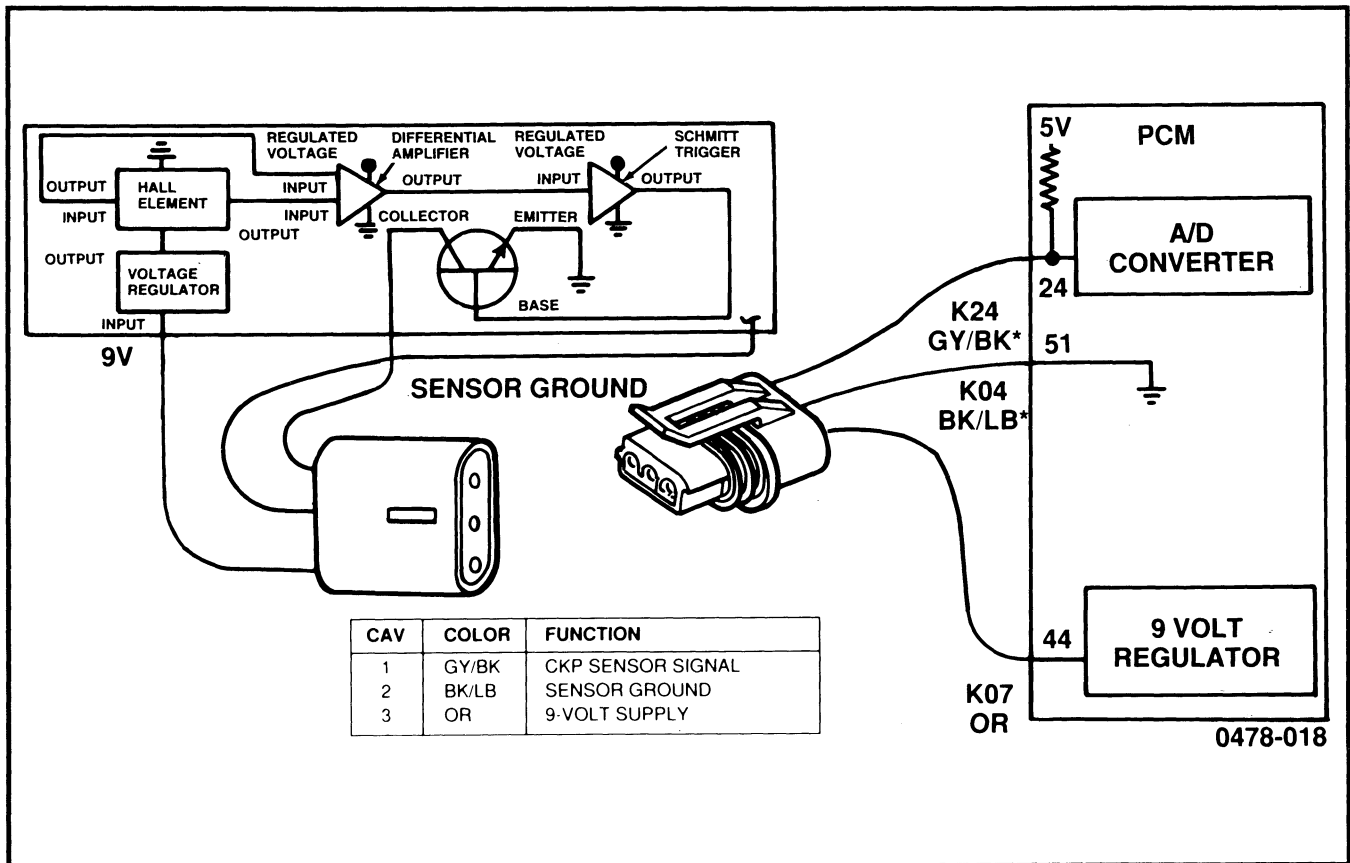
Figure 18 Crankshaft Position Sensor circuit

The Crankshaft Position (CKP) sensor, located on the engine block just above the oil filter, is a Hall-effect sensor that provides a voltage signal to the PCM at pin 25. Voltage alternates between 0 and 5 volts as the crank turns. The PCM supplies 9 volts to the sensor through pin 44, and a sensor ground at pin 51 (fig. 18).

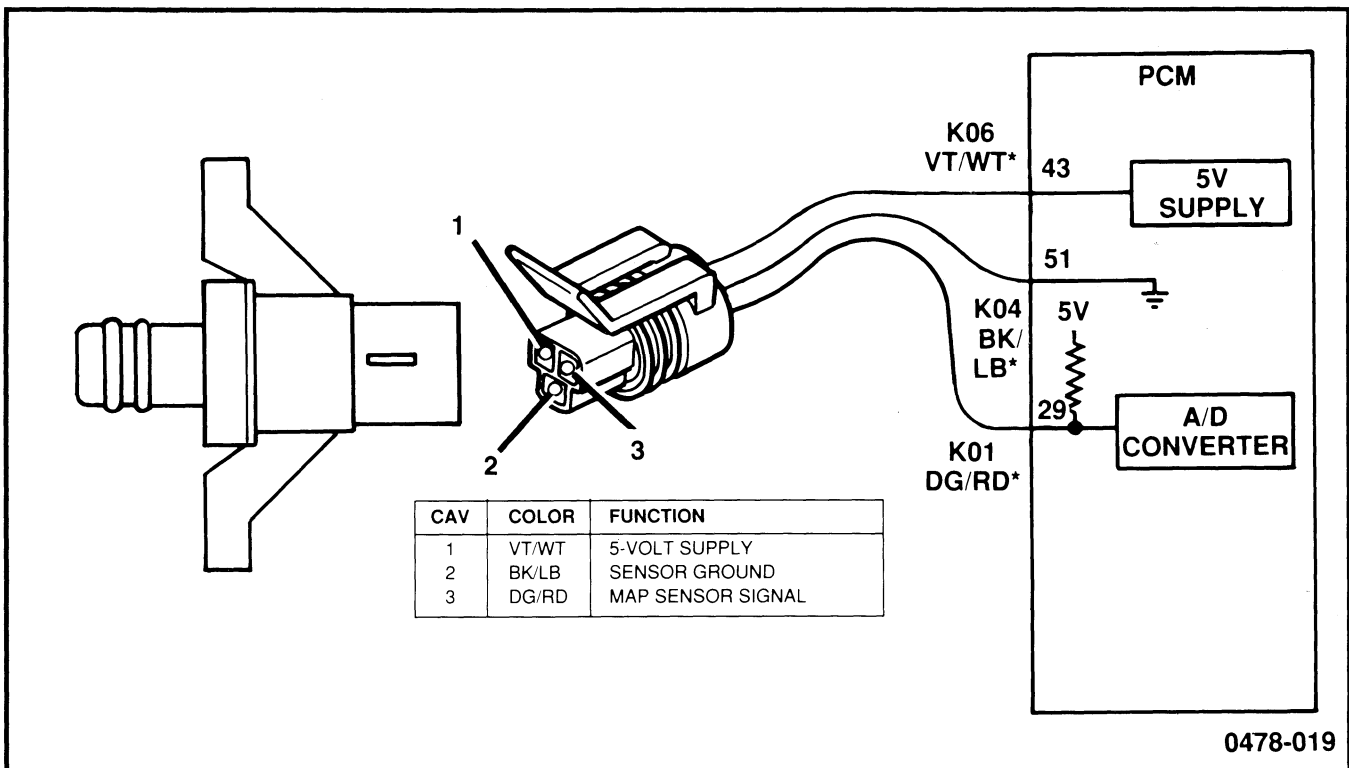
Figure 19 MAP Sensor Circuit

The Neon's MAP sensor is mounted directly to the plastic intake manifold, between the runners for cylinders 1 and 2. It serves as a PCM input at pin 29, receiving 5 volts from the PCM at pin 43, with sensor ground at pin 51 (fig. 19). When the key is turned on, the MAP sensor pulls the voltage down. The amount of voltage drop is based on the barometric pressure of the day (key-on baro. reading). This value is then stored in the PCM's memory, where it can be used to perform several calculations, including the pulse-width calculation. When the engine is started, the manifold pressure should drop, causing the MAP sensor's voltage to be pulled even lower. As the load on the engine increases, the pressure in the manifold increases, causing the voltage drop at the MAP sensor to decrease. At WOT, the pressure in the manifold should be at barometric pressure again. During WOT, the PCM is programmed to update its barometric pressure reading stored from the initial key-on reading, and it updates again, every time WOT is indicated.

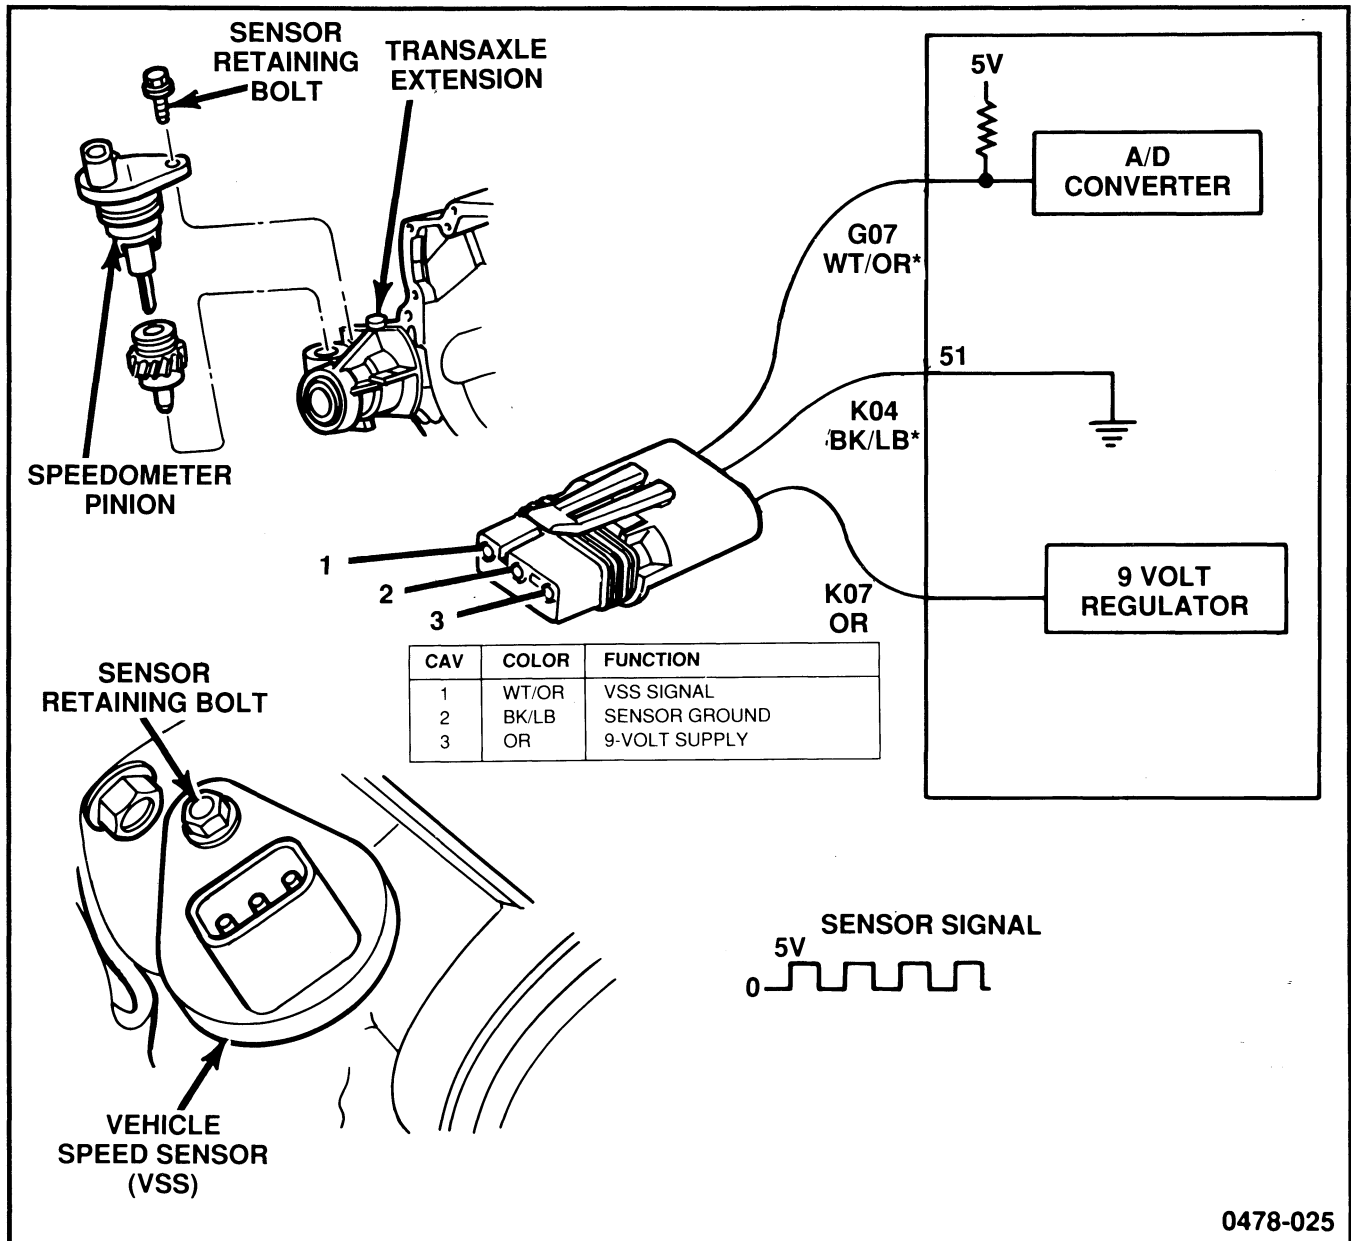
Figure 20 Vehicle Speed Sensor Circuit

The Vehicle Speed Sensor (VSS), is a Hall-effect sensor mounted on the transmission extension housing. It delivers vehicle speed information to the PCM as an input switching voltage between 0 and 5 volts at pin 5 of the PCM's 60-pin connector (fig. 20). When the PCM recognizes 8000 (4000 for Eagle Talon), 0-to-5-volt switching signals, the PCM assumes the vehicle has traveled one mile. The VSS receives a 9-volt power supply from the PCM on pin 44, and is grounded at pin 51.

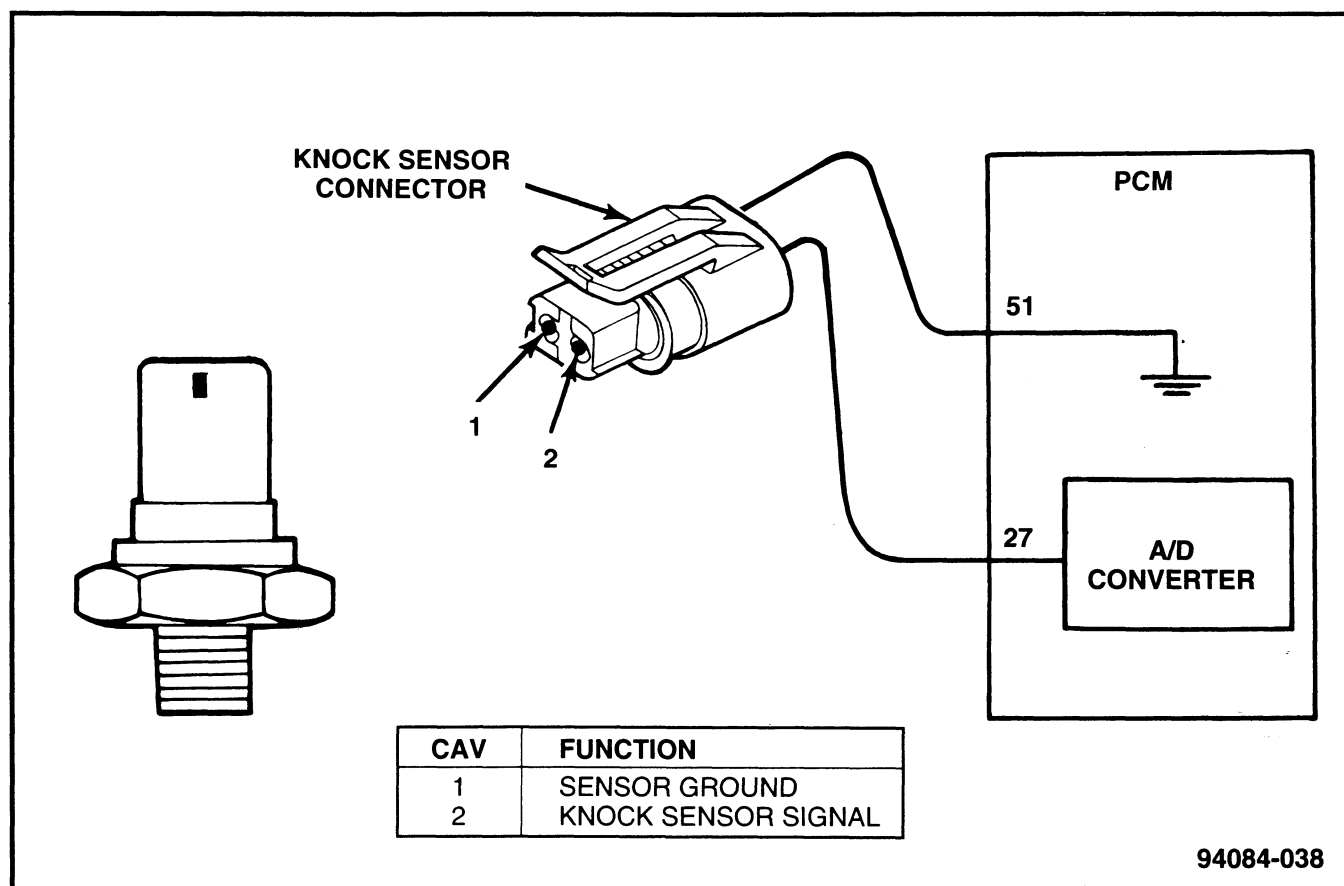
Figure 21 Knock Sensor Circuit

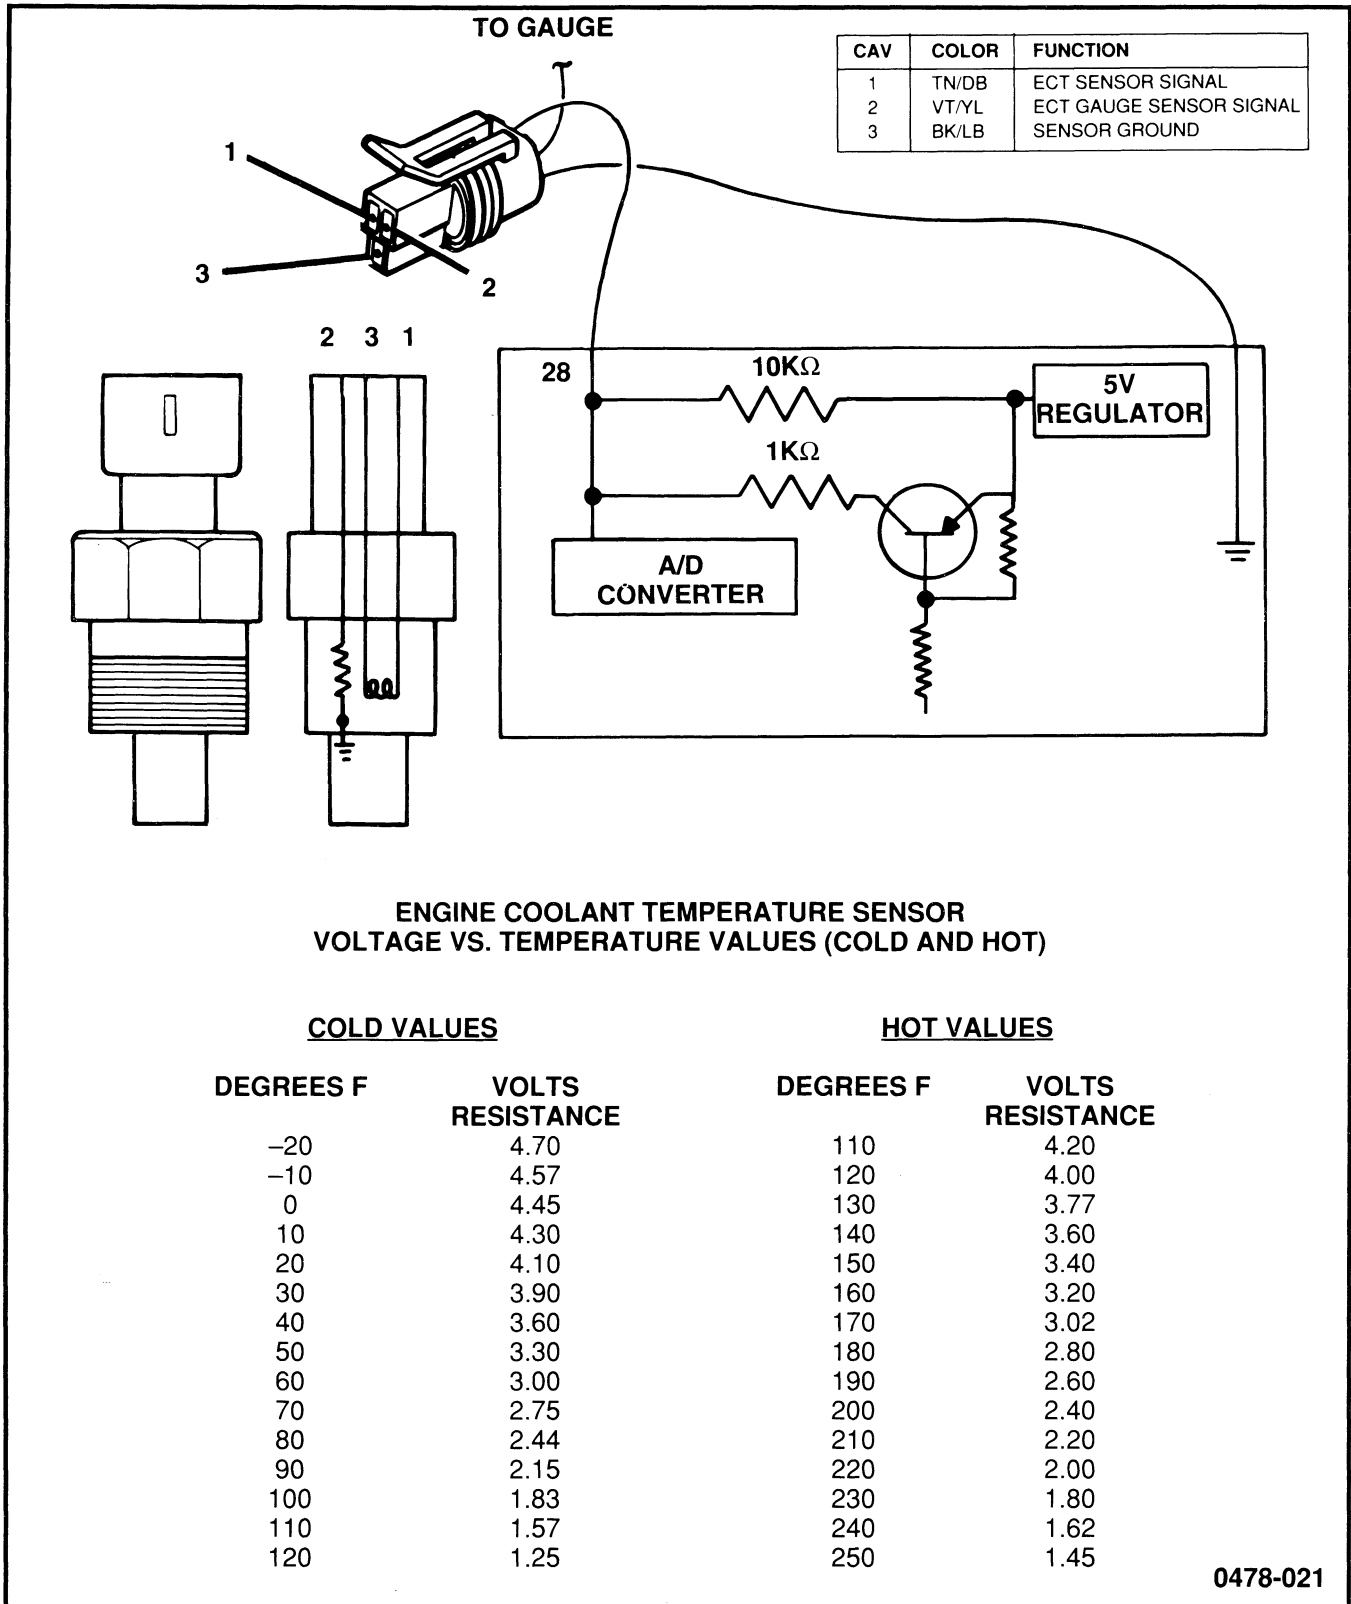
Figure 22 Neon's Engine Coolant Temperature Circuit

The ECT sensor is located on the rear of the cylinder head, just below and to the left of the camshaft position sensor. It serves as a PCM input through pin 28 (fig. 22 and 23). Data from the coolant temperature sensor is used in most fuel and spark related control functions.
