*On Board
Diagnostics*

**CHRYSLER
CORPORATION**

On-Board Diagnostics

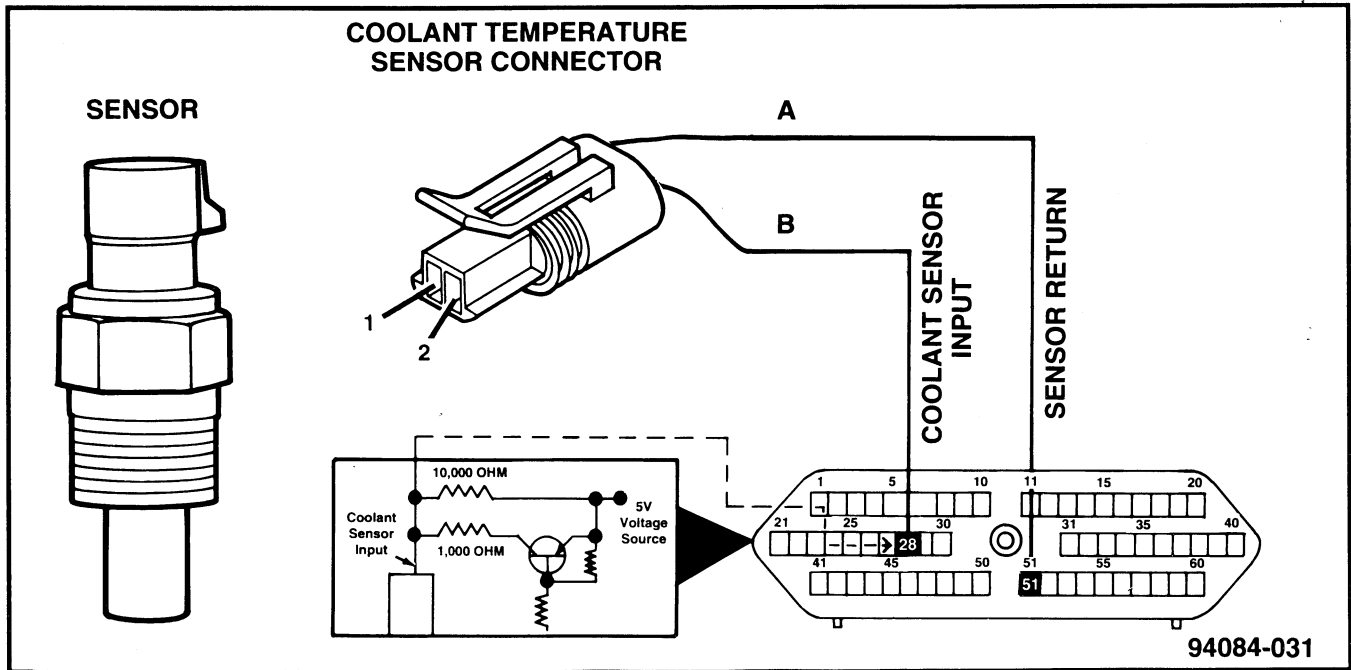
Figure 23 Eagle Talon's Engine Coolant Temperature Sensor Circuit

The ECT sensor is located on the rear of the cylinder head, just below and to the left of the camshaft position sensor. It serves as a PCM input through pin 28 (fig. 22 and 23). Data from the coolant temperature sensor is used in most fuel and spark related control functions.

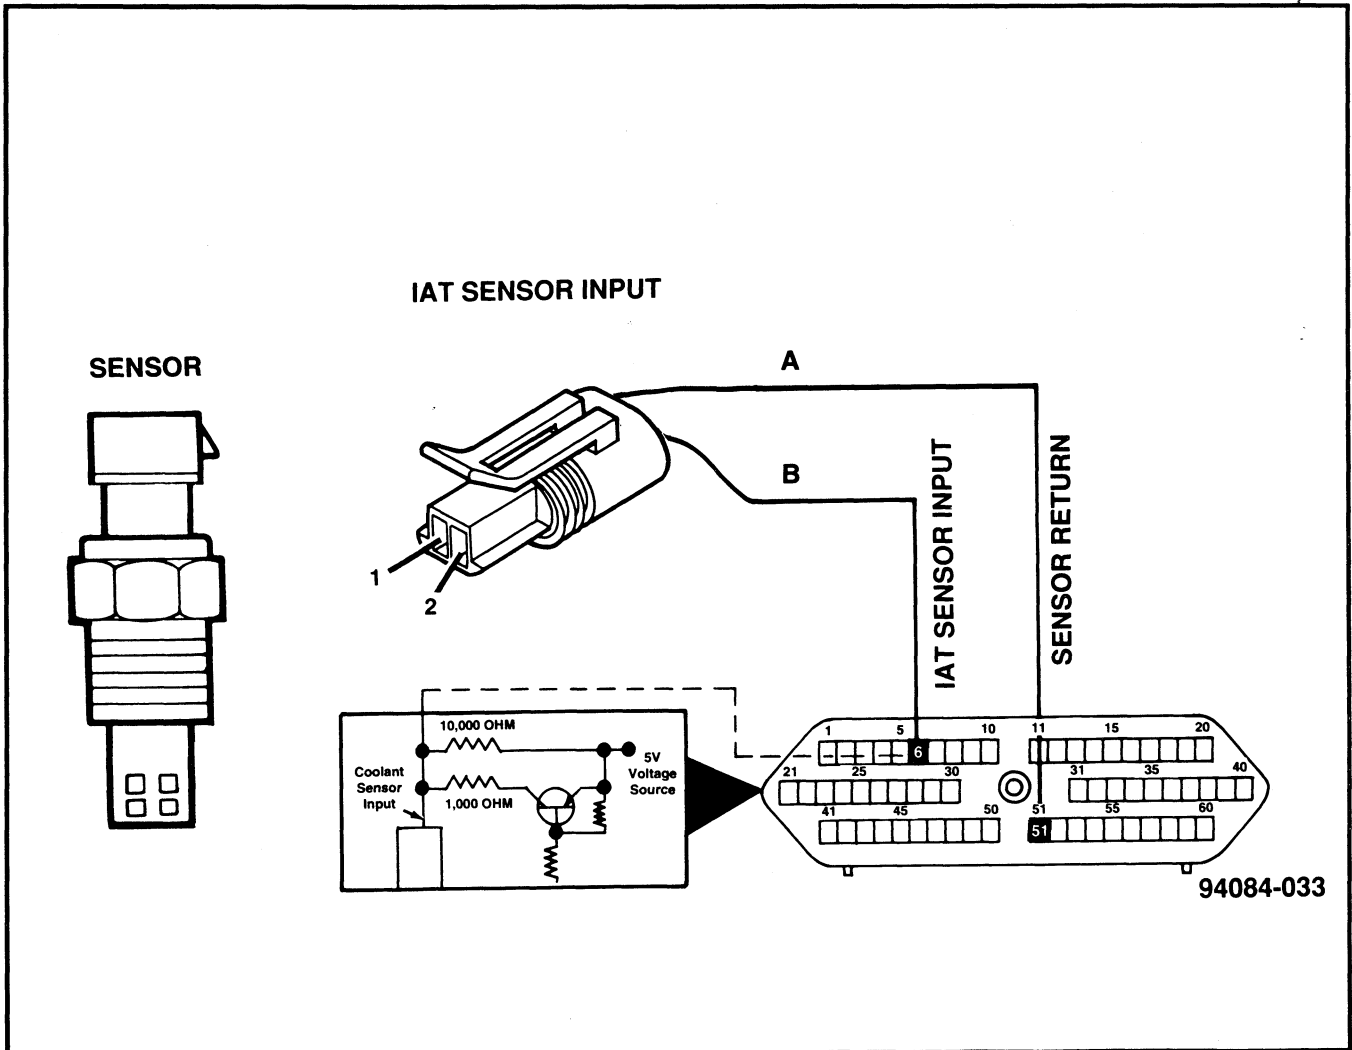
Figure 24 Intake Air Temperature Circuit

Mounted on the plastic intake manifold, the Intake Air Temperature (IAT) sensor serves as a PCM input at pin 6 (fig. 24). When the fuel system is in the open loop mode, the O₂ sensor cannot be used for injector pulse width calculation. In this instance, the system uses information on air mass to determine the correct pulse width necessary to achieve the proper air/fuel ratio. Once in closed loop, the IAT is used by the PCM to assist in air/fuel and spark advance calculations. Because air mass is related to temperature, information from the IAT sensor is used.

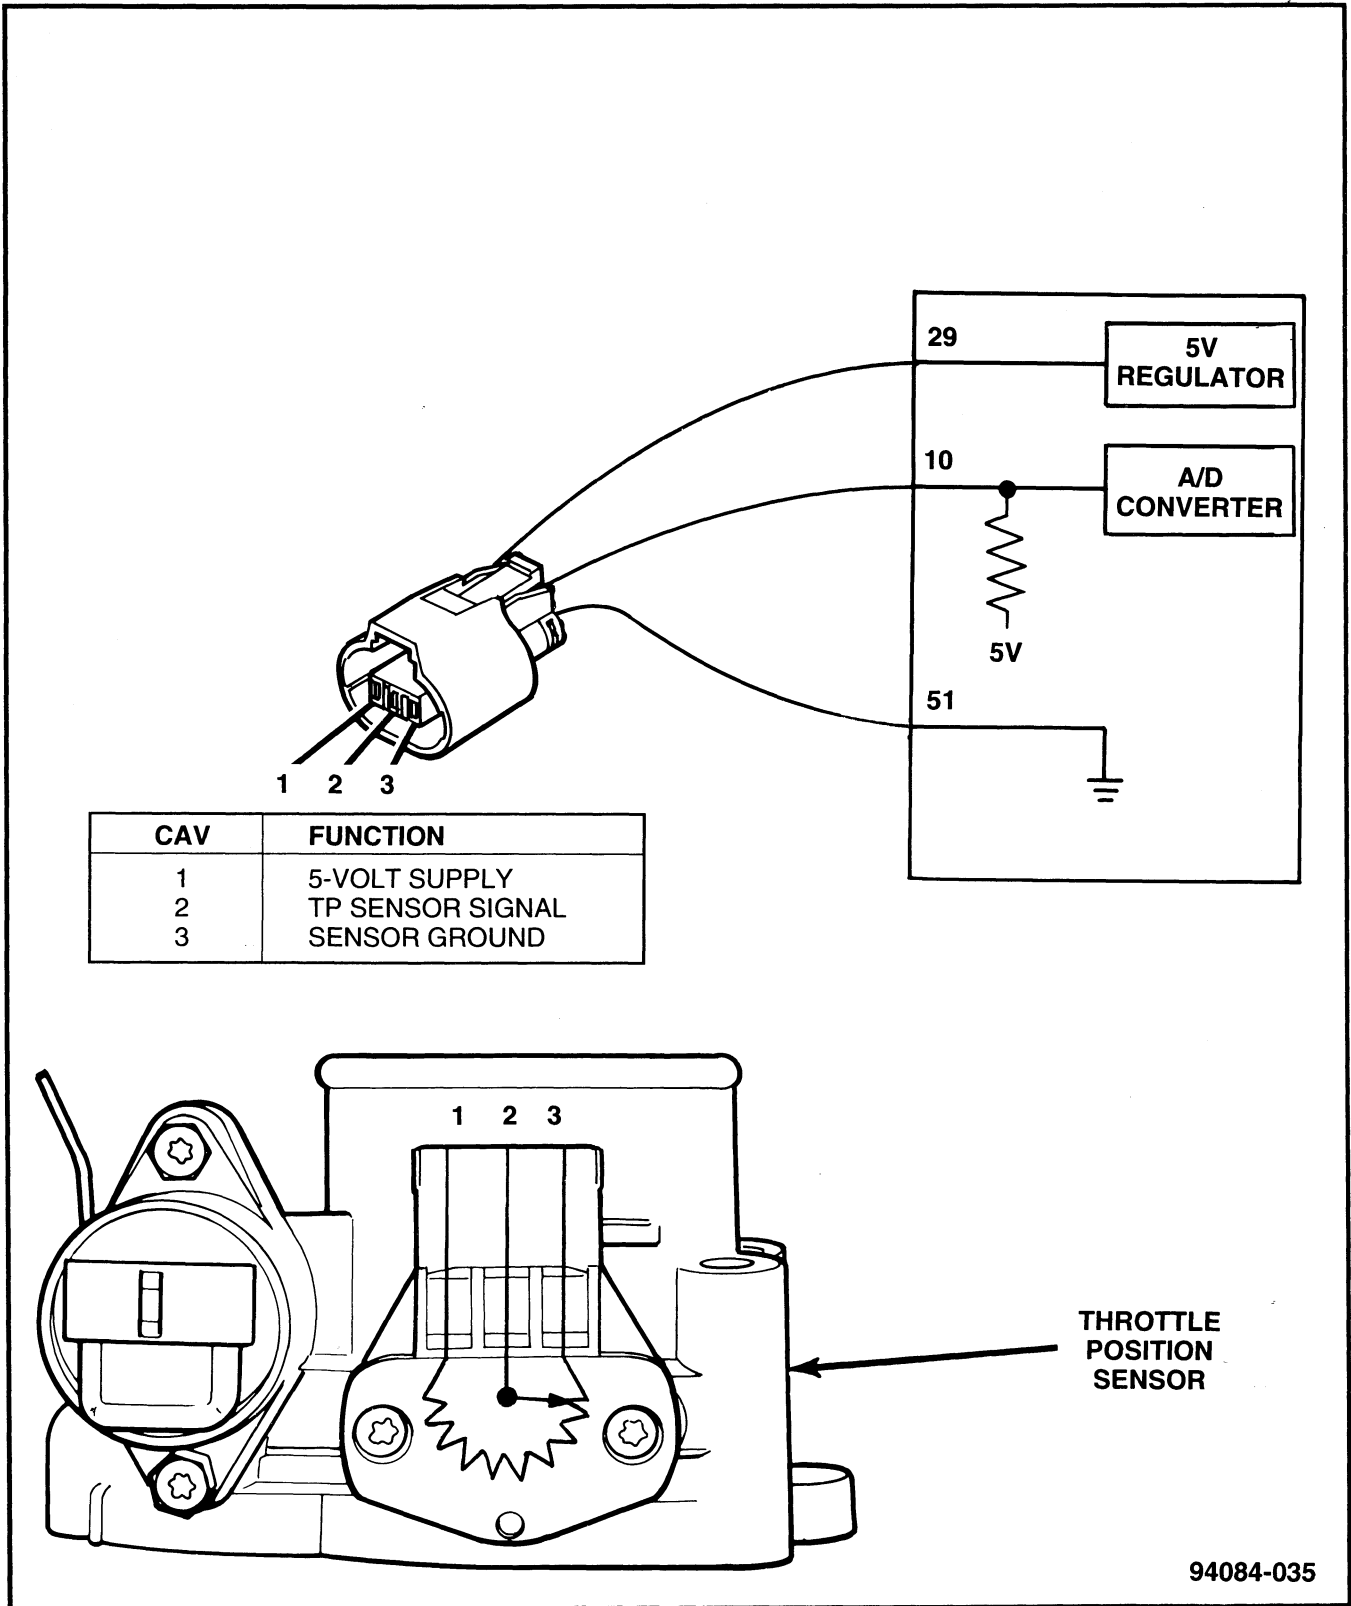
Figure 25 Throttle Position Sensor Circuit

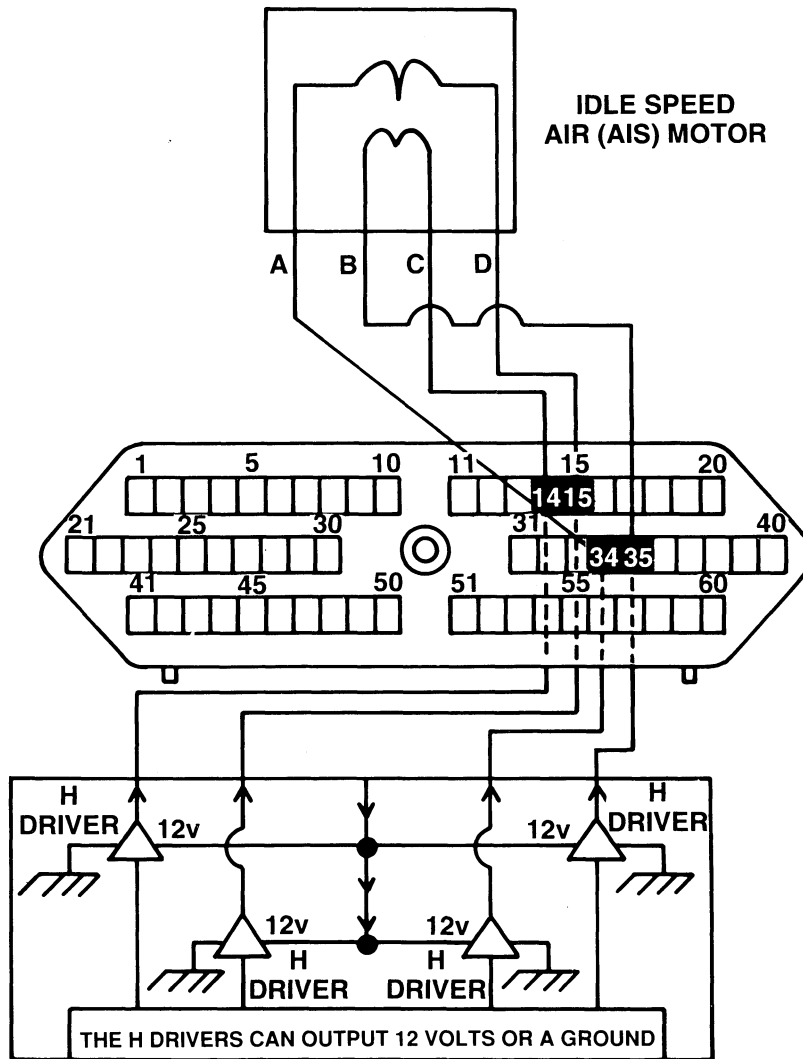
94084-067

Figure 26 Idle Air Control Motor Circuit

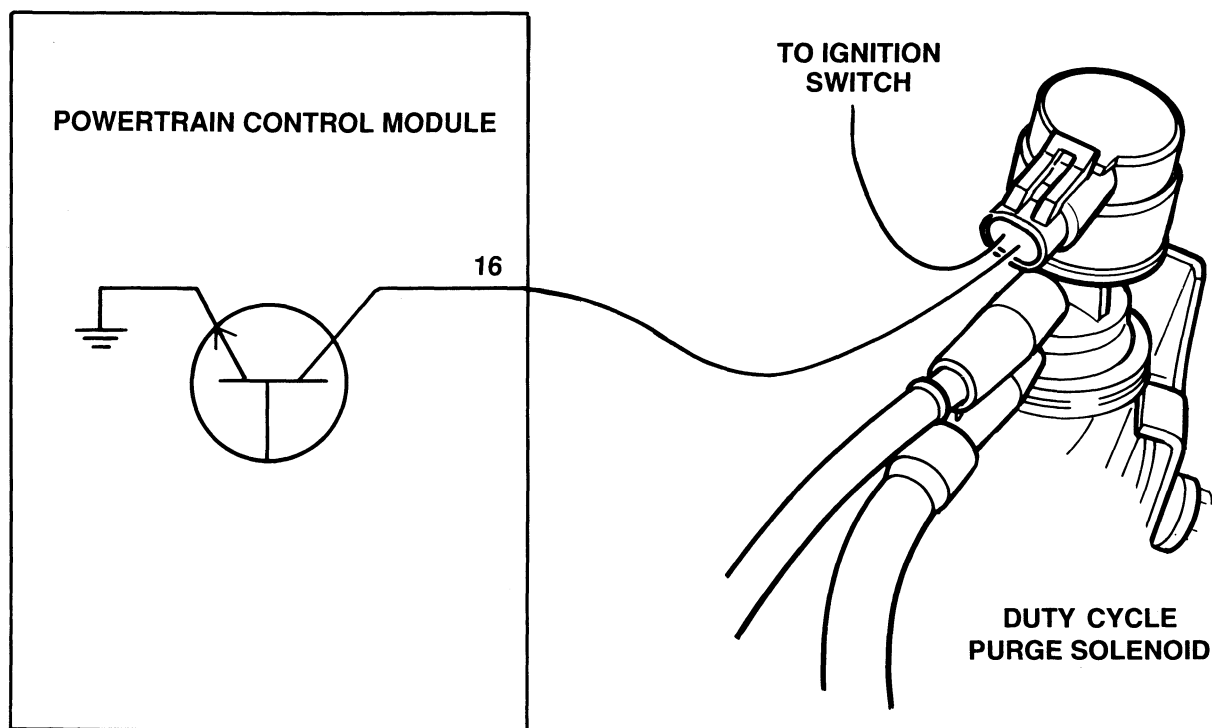
94084-006

Figure 28 Evaporator Purge Solenoid Circuit

The evaporative purge solenoid is mounted on the passenger side of the engine compartment. It is operated as a PCM output, with pin 16 (fig. 28), providing a switched ground path once the vehicle enters closed loop operation. The PCM operates the ground control side of the evaporative purge solenoid at a duty cycle (ON and OFF several times a second). With the solenoid energized, vapors are allowed to be purged from the canister.

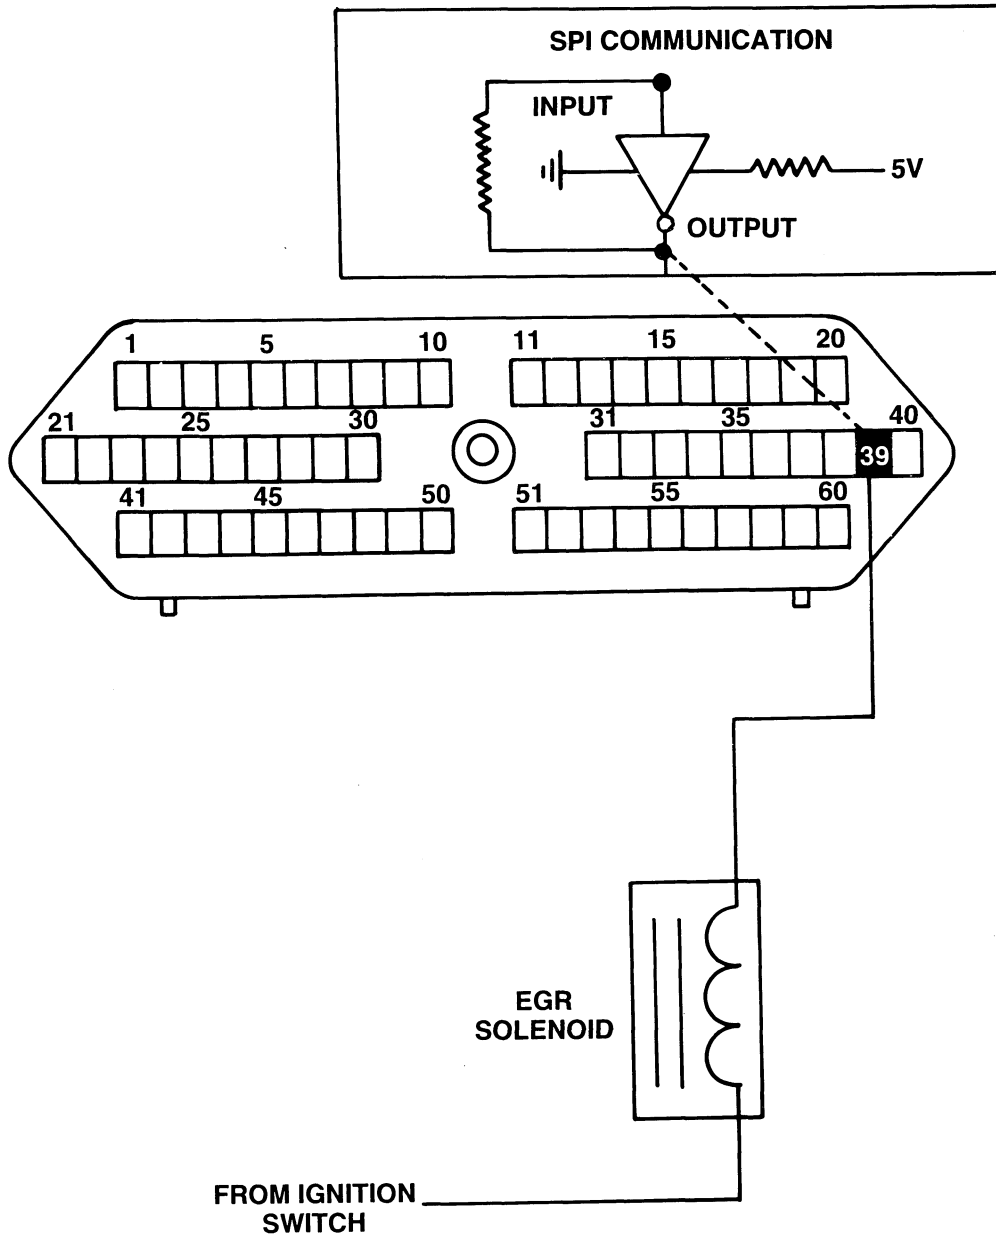
94084-069

Figure 29 EGR Solenoid Circuits

The EGR solenoid is mounted on the transducer, located at the back of the cylinder head, near the camshaft position sensor. The PCM provides a switched ground path to the solenoid through pin 39 (fig. 28). When the EGR solenoid is energized, vacuum is blocked from entering the transducer. As the engine warms up, the PCM de-energizes the EGR solenoid, applying vacuum to the back-pressure transducer. The back-pressure transducer controls the amount of vacuum to the EGR valve based upon the back pressure in the exhaust system.

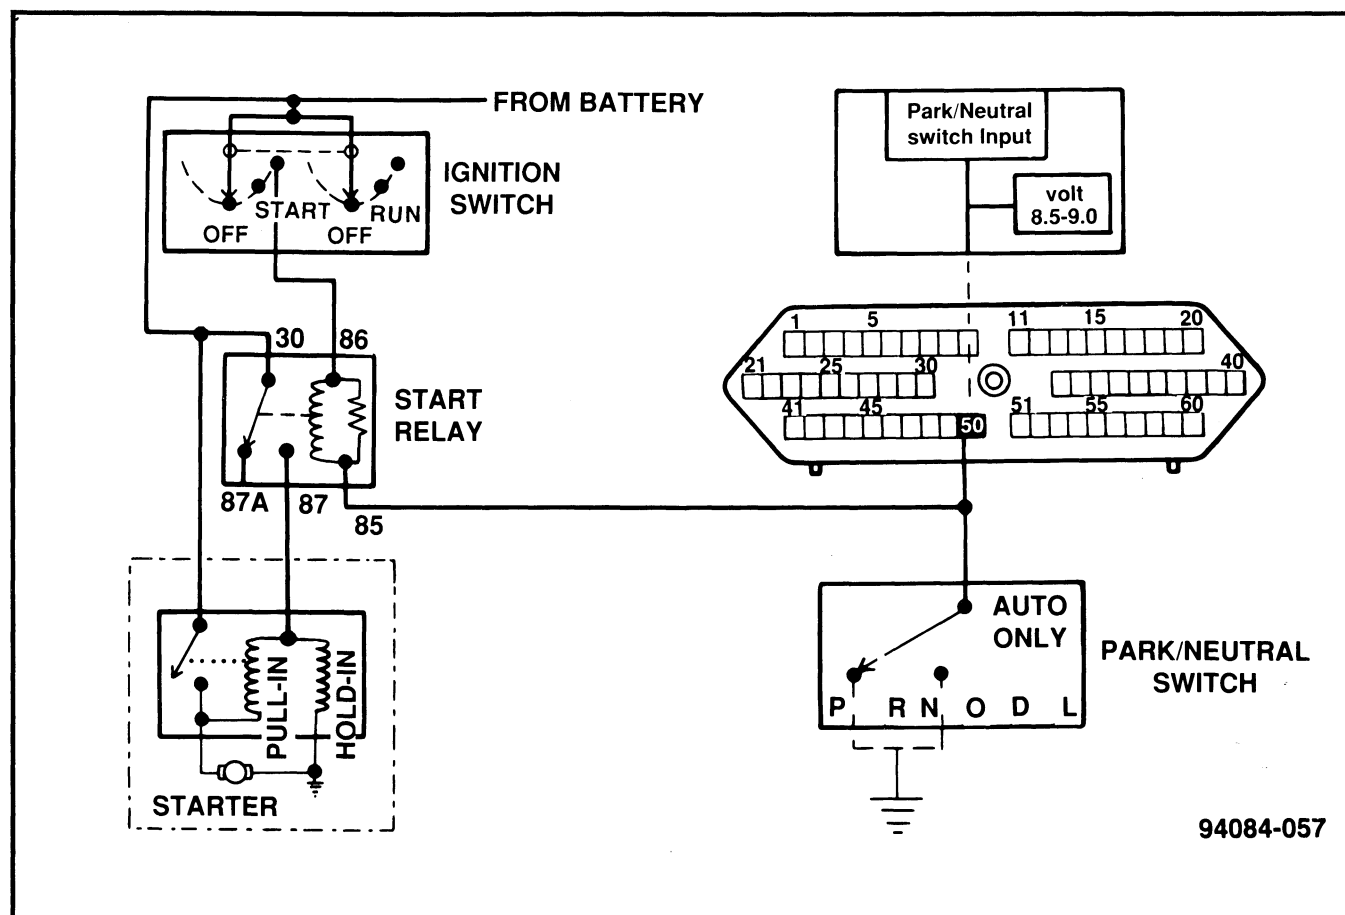
Figure 33 Park/Neutral Circuit

The MIL illuminates and a DTC is stored any time the PCM requests that the solenoid be activated and the voltage at pin 20 of the PCM is high, or when the PCM request that the solenoid be de-energized and the voltage at pin 20 is low (fig. 33). For either condition, the malfunction must be maintained for at least three seconds for the MIL to illuminate and a DTC to be stored.

(Automatic transmissions only) The PCM sends out 9 volts from pin 50 to the park/neutral switch. If the switch is positioned in either park or neutral, the voltage is pulled to ground through the switch. If the park/neutral switch is positioned in any other gear, the circuit is opened, allowing the PCM to recognize the 9-volt signal (fig. 33). The diagnostics for the park/neutral switch are divided into two categories. The first is to identify if the park/neutral switch is indicating park or neutral while driving. The second is to identify a condition in which the vehicle is in park or neutral, while the PCM indicates drive or reverse. The conditions necessary to diagnose the first portion of the DTC are listed below:

The PCM recognizes a failed condition when the input at pin 50 indicates either drive or reverse while cranking. The MIL illuminates and a DTC is stored only after the failed condition is indicated and the engine has started.

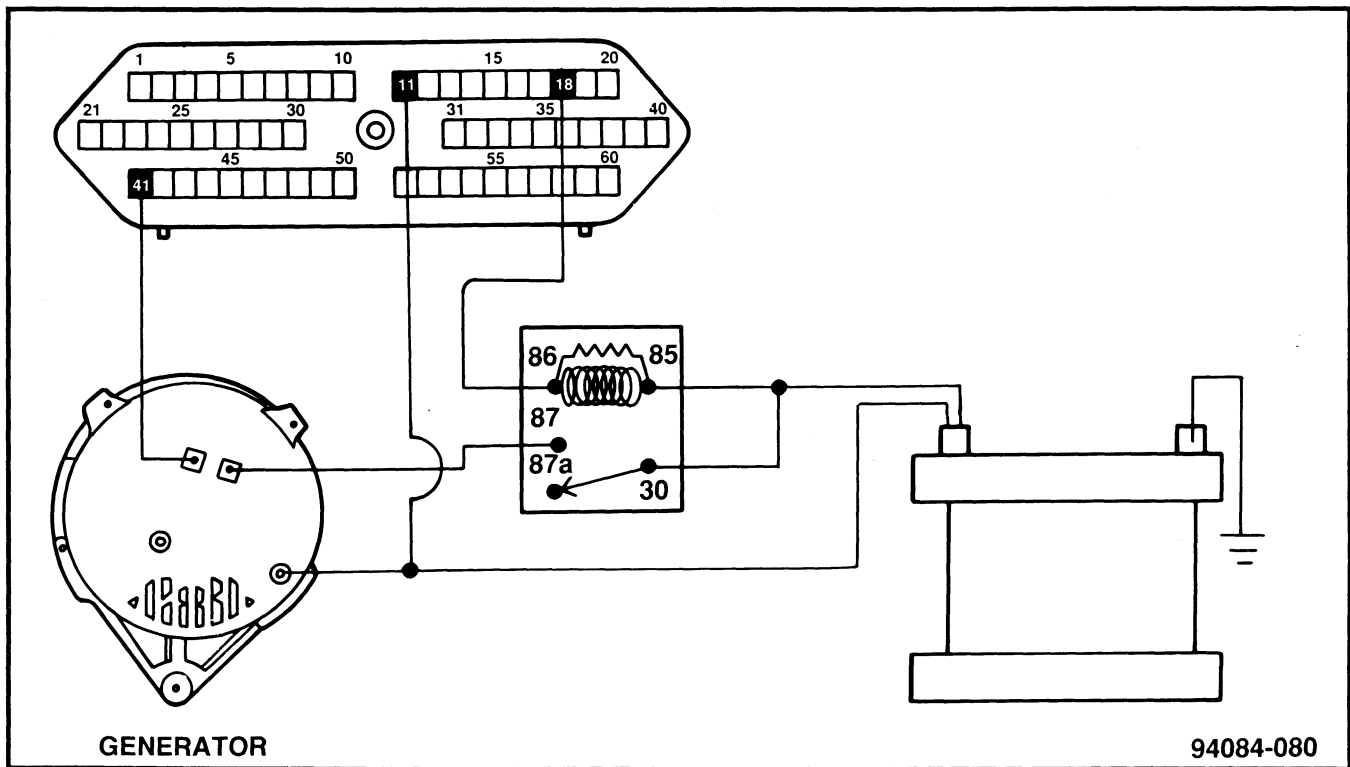
Figure 34 Charging System Circuit

The PCM controls the generator field by duty cycling the ground signal at pin 41. Battery voltage is supplied to the generator field through the ASD relay (fig. 34). The generator output is based upon the total amount of time the field remains grounded.

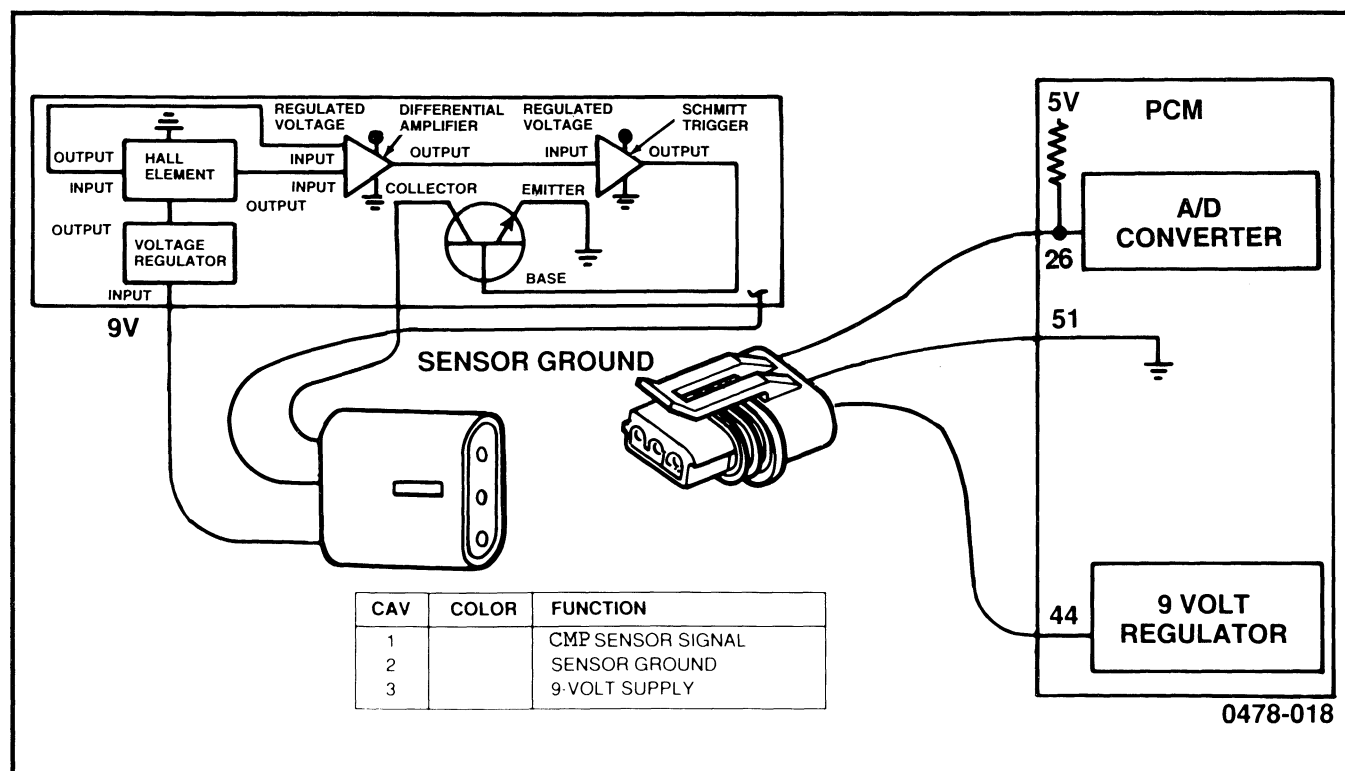
Figure 36 Camshaft Position Sensor Circuit

The camshaft position sensor, mounted on the rear of the cylinder head, is a Hall-effect sensor that provides input to the PCM at pin 26 (fig. 37). The PCM uses information from both the camshaft and crankshaft position sensors (pin 25) to determine injector synchronization and cam/crank synchronization. When the camshaft signal is lost, the PCM relies on the crankshaft signal to allow engine operation. This could result in fuel injection being 180° out of phase, which would result in deterioration of engine performance and an increase in emissions. Also, with the cam signal lost, cranking time may increase.

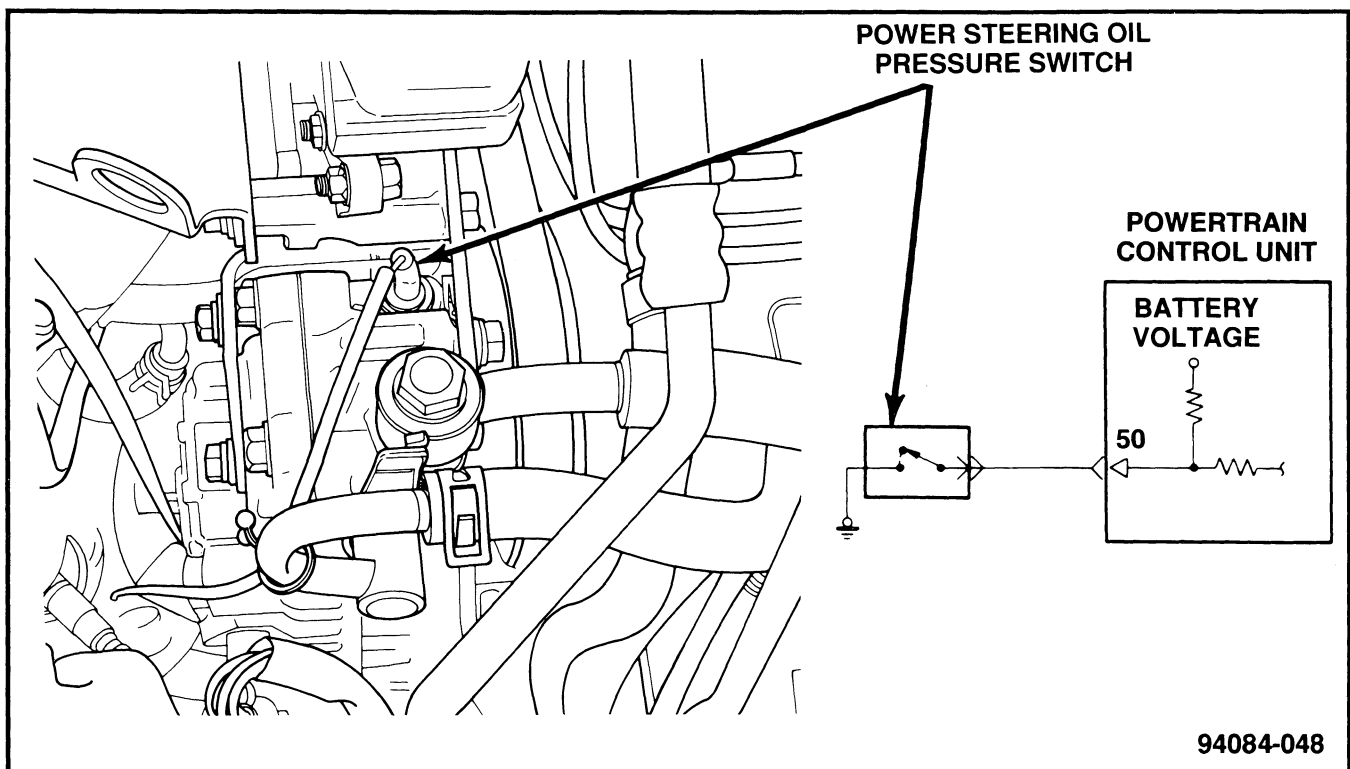
Figure 37 Power Steering Pressure Switch Circuit

The power steering switch serves as a PCM input at pin 56 (fig. 37). Data from this switch allows the PCM to compensate for the additional engine load during steering maneuvers that require high steering pump pressure.

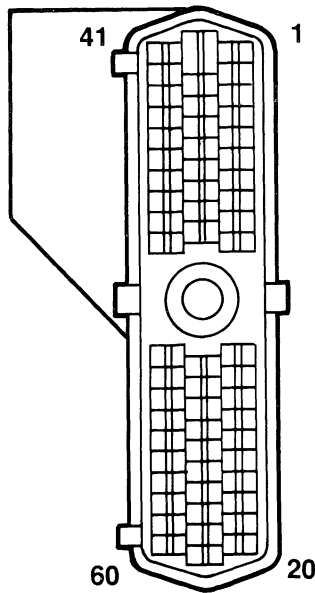
Neon 60-Way Connector

VIEWED FROM
TERMINAL END

CAV	CIRCUIT	FUNCTION
1	K19 20BK/GY*	IGNITION COIL DRIVER
2	Z12 20BK/TN*	POWER GROUND
3	K13 20YL/WT*	FUEL INJECTOR #3
4	K11 20WT/DB*	FUEL INJECTOR #1
5	G7 20WT/OR*	VEHICLE SPEED SENSOR
6	K21 20BK/RD*	INTAKE AIR TEMPERATURE SENSOR
7	K141 20DG/BK*	HEATED OXYGEN SENSOR 2 (DOWNSTREAM)
8	K141 20BK/DG	HEATED OXYGEN SENSOR 1 (UPSTREAM)
9	D20 20LG	DATA LINK
10	K22 20OR/DB*	THROTTLE POSITION (SENSOR)
11	A14 18RD/WT	BATTERY FEED
12	-	-
13	G4	FUEL LEVEL SENDING UNIT
14	K60 20YL/BK*	IDLE AIR CONTROL #2
15	K39 20GY/RD*	IDLE AIR CONTROL #3
16	K52 20PK/BK*	EVAP/PURGE SOLENOID
17	K54 20OR/BK*	TRANSMISSION TCC LU SOLENOID
18	K51 20DB/YL*	AUTOMATIC SHUTDOWN RELAY
19	C27 20DB/PK*	FAN CONTROL RELAY
20	-	-
21	K17 20DB/YL*	IGNITION COIL DRIVER
22	Z12 20BK/TN*	POWER GROUND
23	K12 20TN	FUEL INJECTOR #2
24	K14 20LB/BR*	FUEL INJECTOR #4
25	K24 20GY/BK*	CRANKSHAFT POSITION SENSOR
26	K44 20TN/YL*	CAMSHAFT POSITION SENSOR
27	K42 20BK/LG*	KNOCK SENSOR
